SOUTHERN CALIFORNIA
MASTER HOME INSPECTION

Inspection Report Sample#3

PROPERTY INSPECTION REPORT FORM

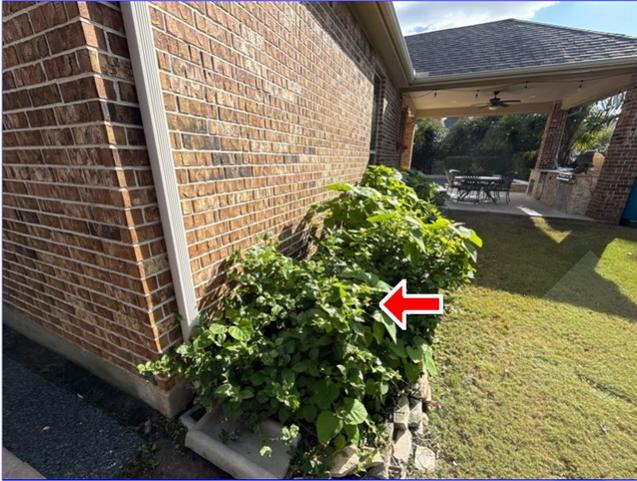
A. Item 1 (Picture) Rear of home

- (1) This is not an engineering report, but is only an opinion based on observation of conditions known to be related to foundation performance, using the knowledge and experience of the inspector.
- (2) There is vegetation obstructing clear visibility of the foundation. This limits the full inspection of the

foundation conditions and can create conducive conditions for certain types of wood-destroying insects. I recommend removing vegetation and having a qualified professional inspect the foundation, and having a licensed pest control company inspect and treat as needed.

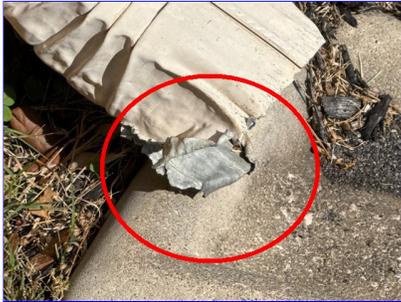
B. Item 1 (Picture) Left side of home

The downspout is damaged. Further deterioration can occur. I recommend having a qualified person make repairs as needed.

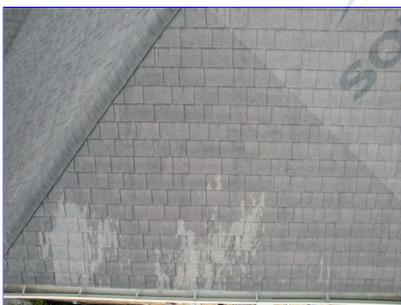
C. Item 1 (Picture) "whole" roof surface

- (4) The roof shingles are showing wear and granular loss (Granules provide UV protection for shingles. Once the granules erode away, the sun is able to deteriorate the asphalt and shorten the life of the roof covering). Further deterioration can occur. I recommend having a qualified roofing contractor further evaluate and make repairs or replace as needed.

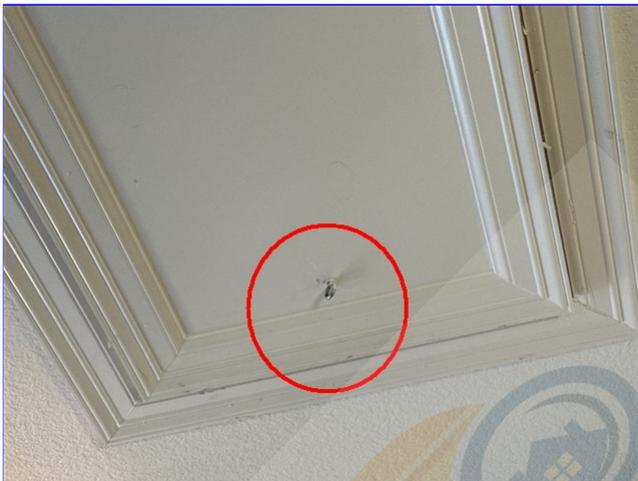
D. Item 1 (Picture) Attic opening

(2) The pole for attic opening is missing. I recommend a qualified person to repair as needed.

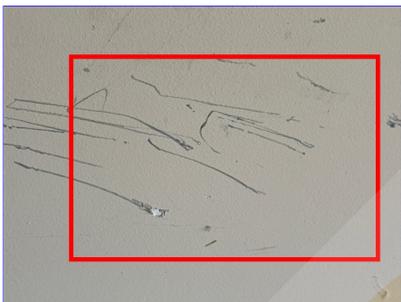
E. Item 3 (Picture) Garage in multiple areas

(1) The wall is dirty/ peeling paint/ deteriorated/ damaged. While this damage is cosmetic, it should be repaired. I recommend having a qualified professional make repairs or replace as needed.

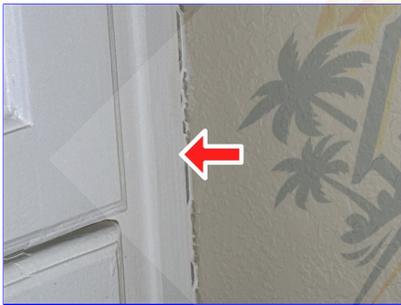
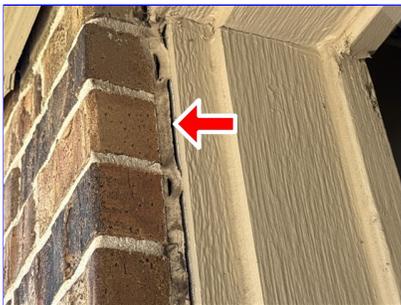
(3) The exterior has caulking that is weathered or missing. Water intrusion and deterioration can occur. I recommend having a qualified person make repairs as needed.

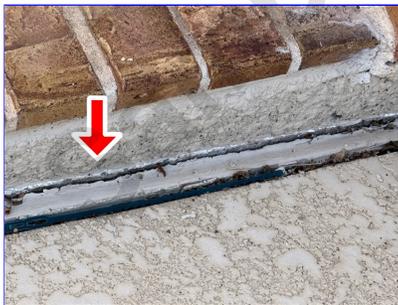
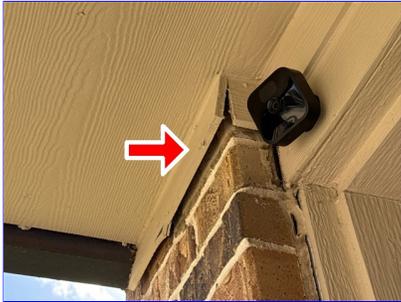
(4) The exterior trim is loose, damaged or deteriorated in areas. Water intrusion and further deterioration can occur. I recommend having a qualified professional make repairs as needed.

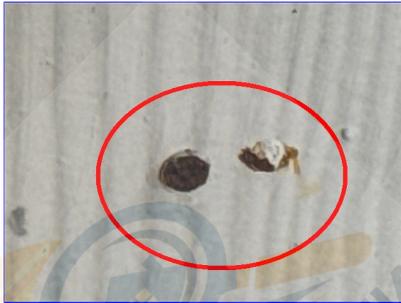
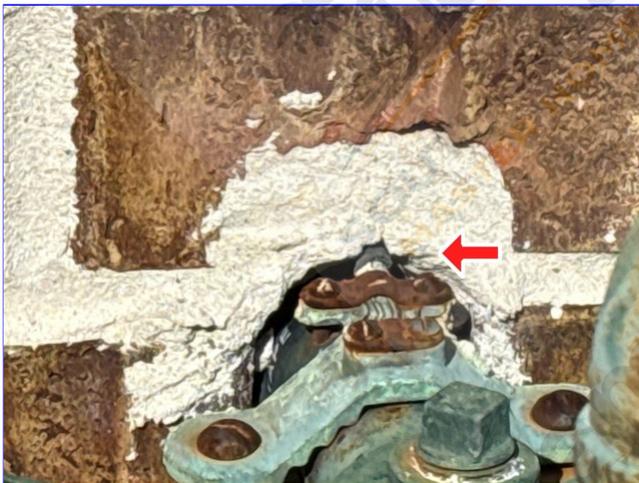
(5) Areas where wiring or piping passes through walls have missing or deteriorated caulking. This can cause water intrusion and deterioration. I recommend having a qualified person make repairs as needed.

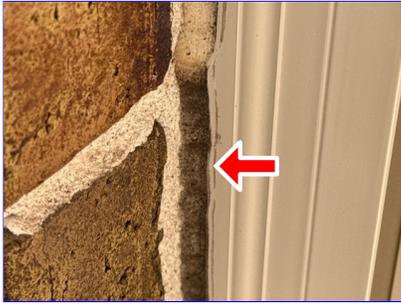
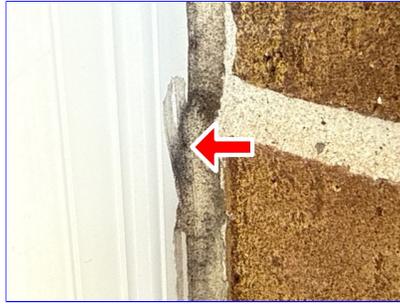
(6) There are signs of fungal growth on the exterior. We did not inspect, test, or determine if this growth is or is not a health hazard. The underlying cause is moisture. I recommend having a licensed mold inspector or expert to inspect, treat, and remediate as needed.

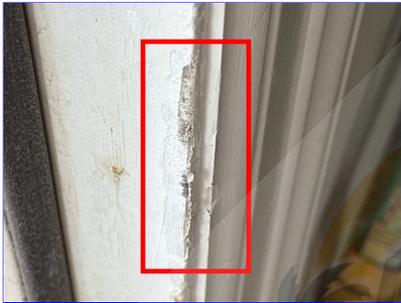
E. Item 18 (Picture) Interior door jamb

(7) The interior trim is damaged, or peeling paint in areas. This is a cosmetic issue. I recommend having a qualified person make repairs as needed.

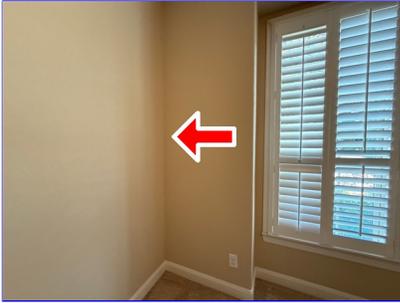
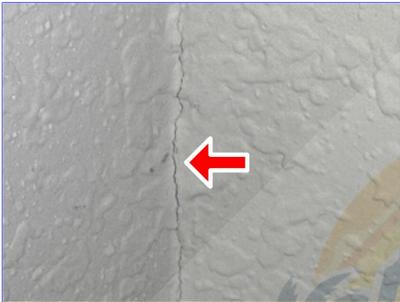
(8) The wall has several hairline cracks. This is a cosmetic issue for your information. I recommend having a qualified person make repairs as needed.

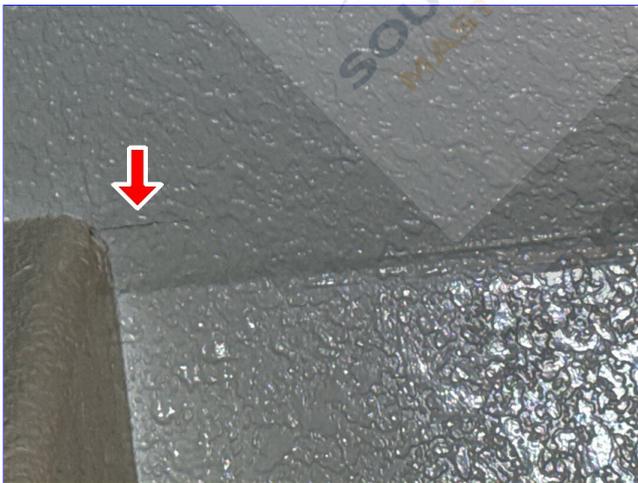
F. Item 1 (Picture) Pantry room

(1) The ceiling reveals tape line and nail bed areas. While this damage is considered cosmetic, it should be repaired. I recommend having a qualified professional make repairs as needed.

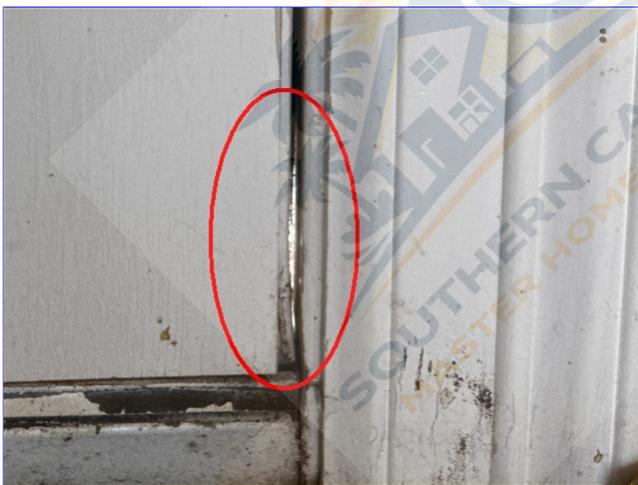
G. Item 1 (Picture) Interior garage door towards backyard

(1) The entry door reveals daylight when latched. This can cause energy loss and water or insect intrusion. I recommend having a qualified person make repairs as needed.

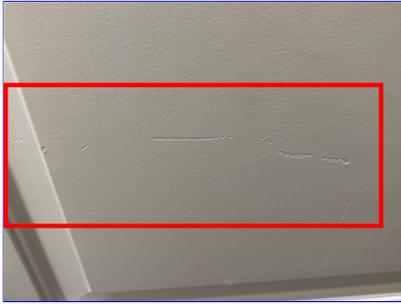
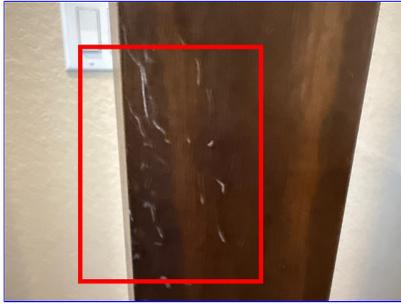
(2) Entry doors peeling paint. I recommend a qualified person to repair as needed.

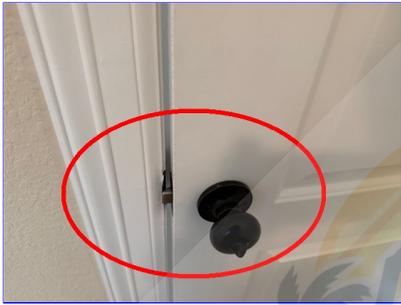
G. Item 4 (Picture) Left side 1st floor guest bedroom (face to front door)

(3) The door does not lock properly and should be adjusted. Further deterioration can occur. I recommend having a qualified professional make repairs or replace as needed.

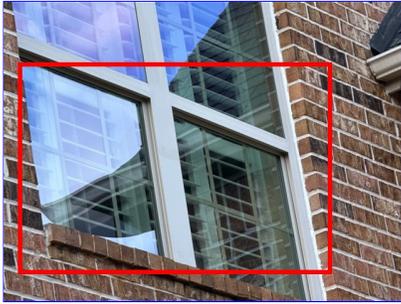
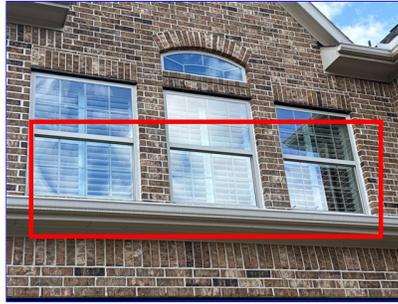
(1) Some windows have damaged or missing screens. This is not considered today's standards. I recommend having a qualified person make repairs as needed.

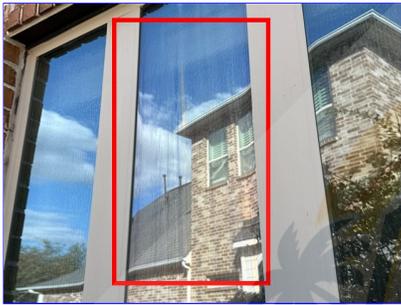
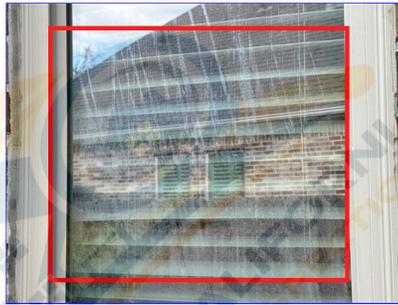
(2) The glazing at glass panes appears to be failing at some windows, causing streaks, condensation, or cloudy glass (If there are multiple windows that are the same age and style, it is safe to assume others may start to fail as well). I recommend having a qualified professional evaluate all windows and make repairs or replace as needed.

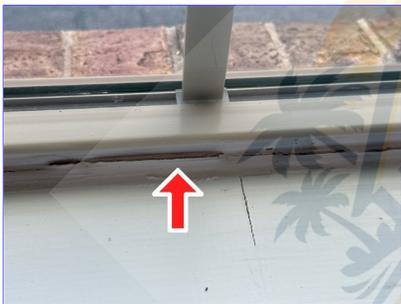
H. Item 9 (Picture) Multiple areas

(3) There are window frames that are not properly sealed. This can cause energy loss, water intrusion and deterioration. I recommend having a qualified person make repairs as needed.

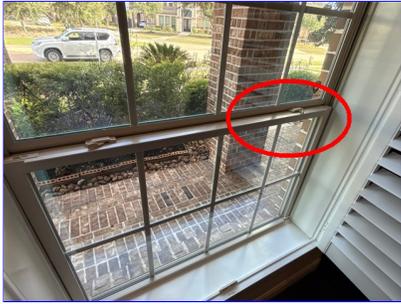
H. Item 10 (Picture) Office

(4) Some windows are not locking properly. This is a maintenance issue and is for your information. I recommend having a qualified person make repairs as needed.

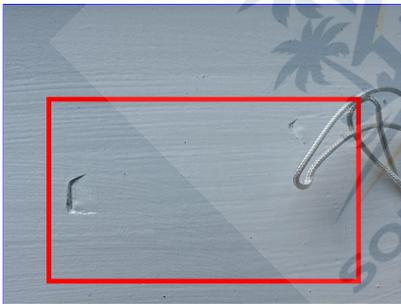
H. Item 14 (Picture) Living room

(5) Window sills deteriorated on the surface. I recommend a qualified person to repair as needed.

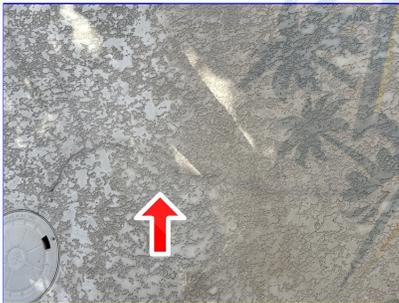
K. Item 1 (Picture) Patio floor at pool area

- (1) The weight load capabilities are not part of this inspection.
- (2) The concrete floor on the patio has cracked in some areas (which are cosmetic). Further deterioration can occur if not repaired. I recommend having a qualified person make repairs as needed.

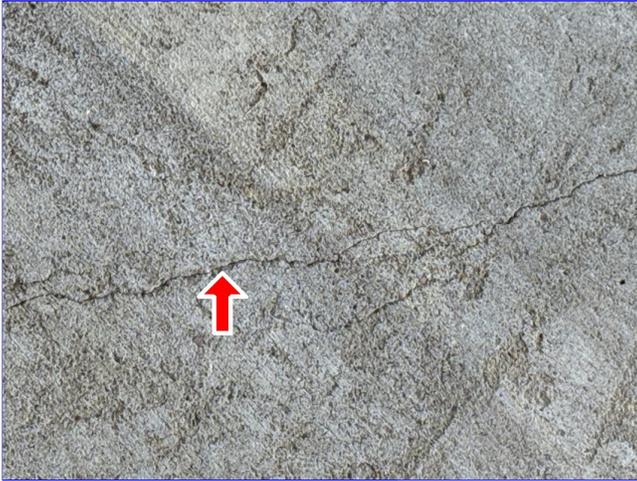
L. Item 1 (Picture) Driveway

(1) The concrete drive has settlement cracks. Further deterioration can occur if not repaired. I recommend having a qualified person make repairs as needed.

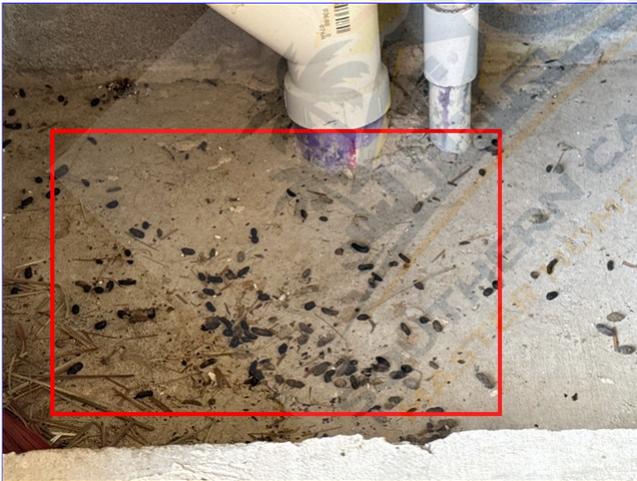
L. Item 2 (Picture) Outdoor kitchen

(2) There is what appears to be an active of rat. I recommend having a qualified licensed pest control company inspect and treat as needed.

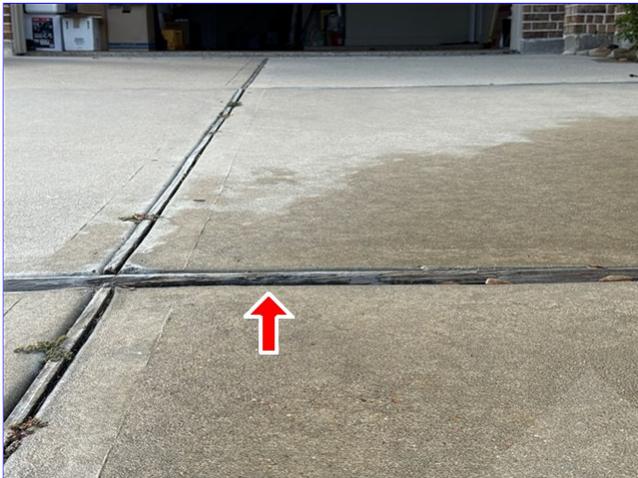
L. Item 3 (Picture) Driveway

(3) The concrete has settlement cracks, is uneven, and can be a potential trip hazard. A fall or injury can occur if not corrected. I recommend having a qualified professional make repairs as needed.

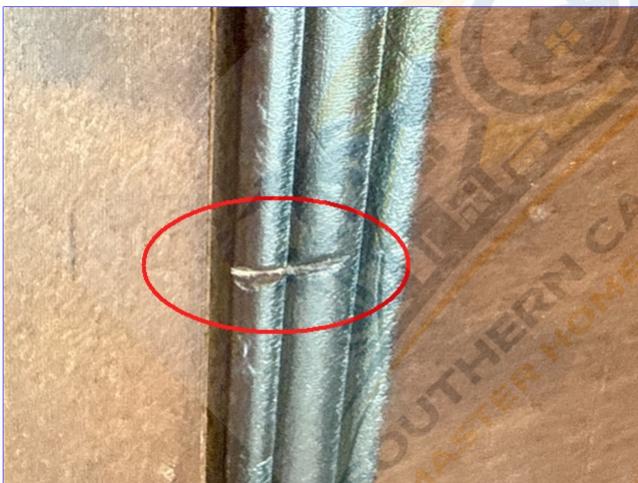
L. Item 4 (Picture) Drawer cover at the breakfast room

(4) There are cabinets that are peeling paint. I recommend having a qualified professional make repairs or replace as needed.

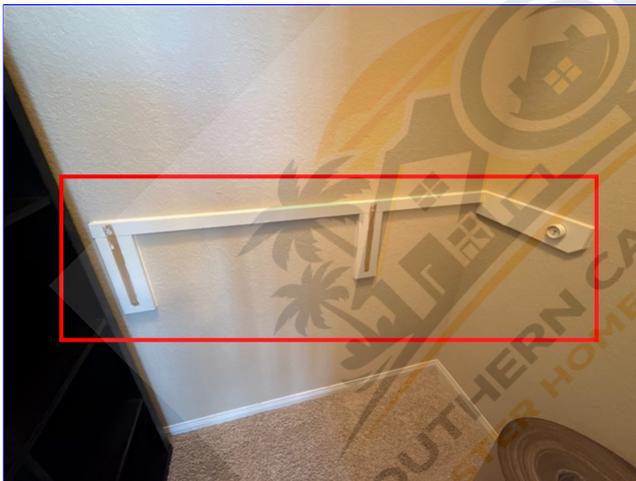
L. Item 6 (Picture) 2nd floor front guest bedroom

(6) Clothing spindle and racks are missing. I recommend a qualified person to repair as needed.

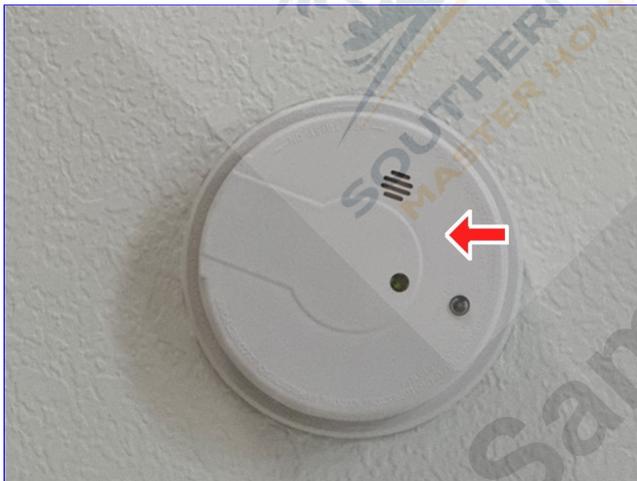
B. Item 1 (Picture) Multiple areas

(1) I recommend checking all smoke detectors for functionality and putting fresh batteries in each unit upon move-in. It is recommended to have smoke detection in each bedroom, hallway, and living area. Carbon monoxide detection is recommended in all homes, especially if equipped with gas-fired appliances. Some detectors may not be available for inspection due to limiting circumstances (ex., wired with an alarm company).

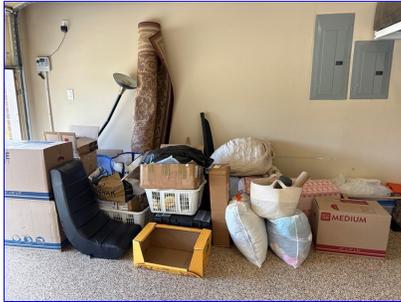
B. Item 2 (Picture) Garage

(2) Did not trip exterior and garage outlets due to occupants' belongings in the garage. This is for your information.

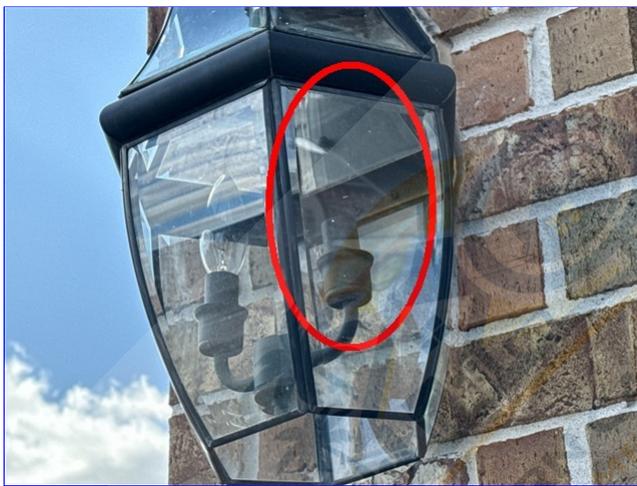
B. Item 4 (Picture) Front of garage

(3) The light fixture is missing globe. This is for your information. I recommend having a qualified person make repairs as needed.

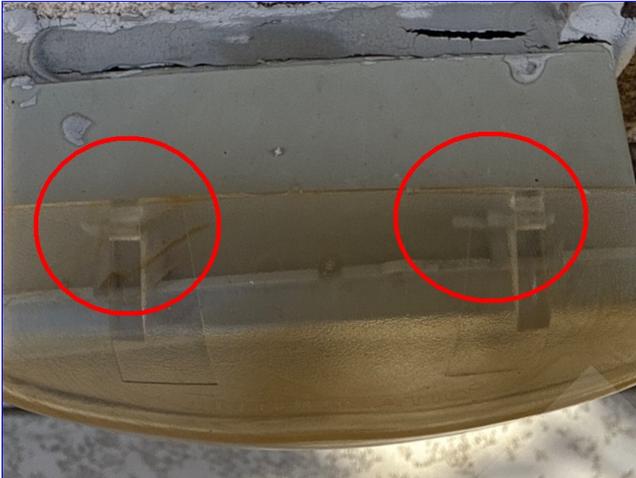
B. Item 11 (Picture) Rear of home

(5) The exterior outlet has a damaged cover. This is for your information. I recommend having a qualified person make repairs as needed.

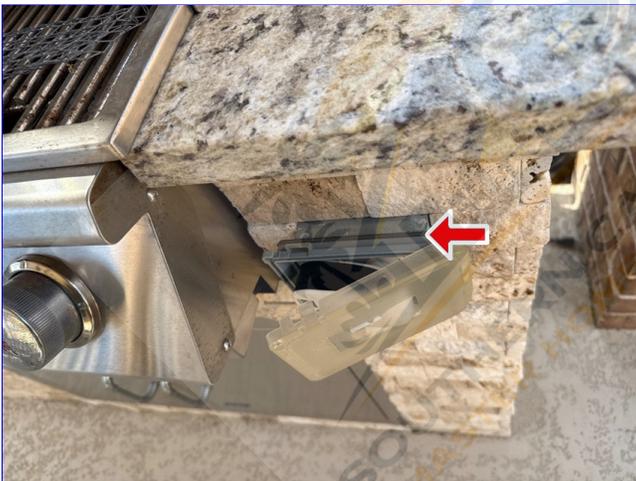
B. Item 12 (Picture) Outdoor kitchen

(6) The exterior outlet loose in the wall, and needs to be secured properly. This is for your information. I recommend having a qualified person make repairs as needed.

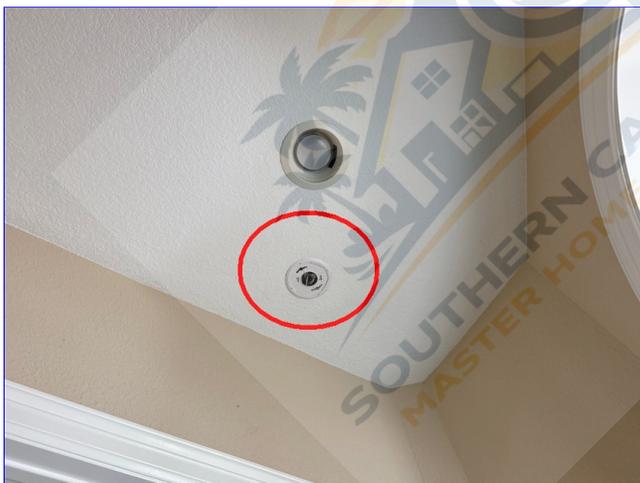
B. Item 14 (Picture) Front of master bedroom

(8) Today's standards state that smoke detectors are required to be in all sleeping rooms, outside sleeping rooms, and on each level of the home. There are missing or non-functioning smoke detectors in the home. I recommend having a qualified professional install smoke detectors in the mentioned areas according to the manufacturer's instructions.

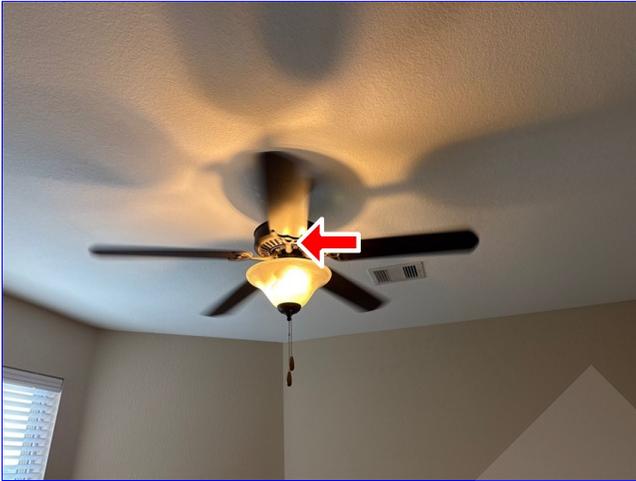
B. Item 15 (Picture) 2nd floor rear guest bedroom

(9) The ceiling fan "wobbles". This is for your information. I recommend having a qualified person make repairs as needed.

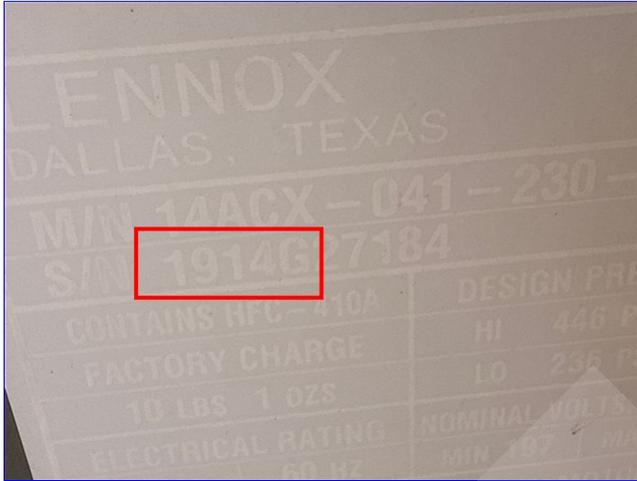
B. Item 5 (Picture) "Lennox" condenser, built in 2014

(3) The condenser outside (AC unit) is built over 10 years and may last a few years more, but maybe not. I have seen units fail shortly after a home inspection during the seasonal change from mild to hot weather. I cannot determine how long your AC will last before a replacement is necessary.

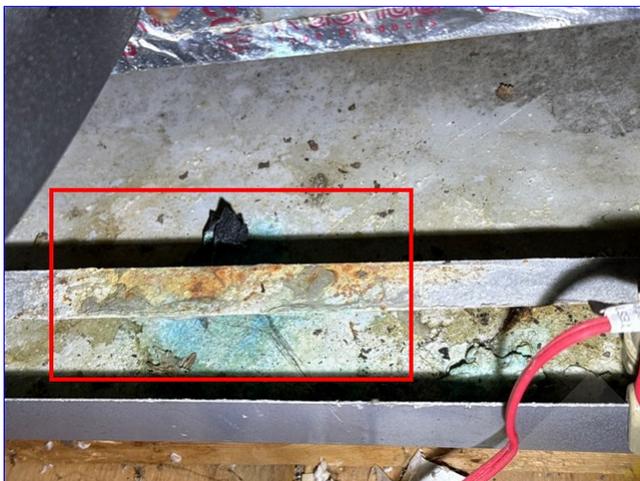
B. Item 10 (Picture) Attic

(5) The emergency overflow drain pan for the HVAC system is showing signs of deterioration. Further deterioration and leaks may occur. I recommend having a qualified professional make repairs or replace as needed.

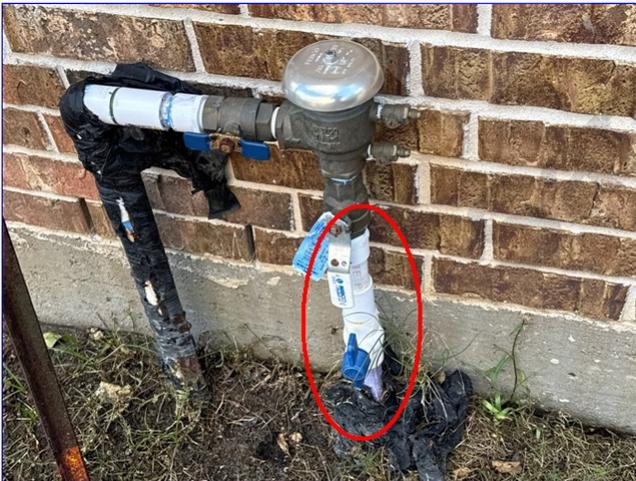
A. Item 4 (Picture) Backflow preventer

(4) The supply line has missing or deteriorated insulation. This can freeze and cause leaks. I recommend having a qualified person make repairs as needed.

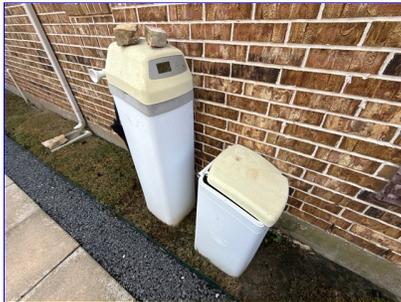
A. Item 5 (Picture) Not inspect

(5) I did not inspect any water filtration or water softener units. I recommend contacting the installer for information on the life expectancy or condition.

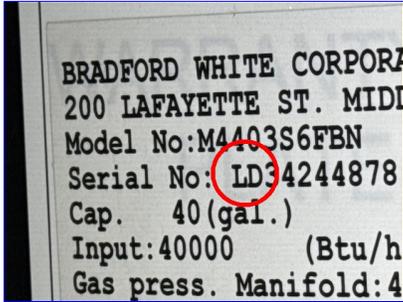
C. Item 1 (Picture) Built in 2014

(2) The water heater is built over 10 years and may at the end of its life expectancy. No leaks at present. I recommend having a qualified licensed plumbing contractor make repairs as needed.

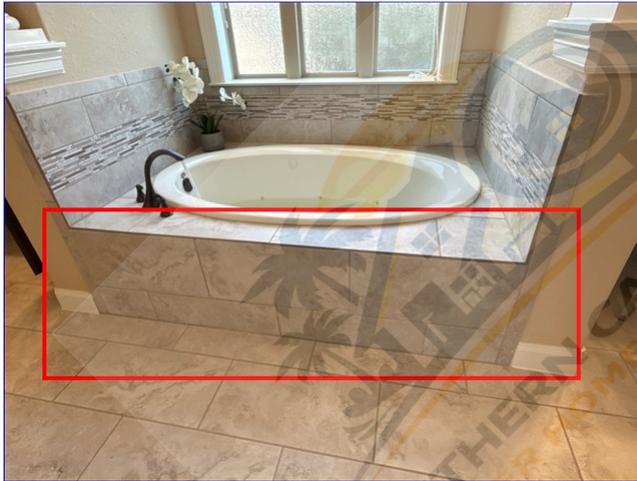
D. Item 1 (Picture) Master bath

(1) The Hydro-Massage Therapy equipment is missing an access panel. I recommend having a qualified professional add an access panel.

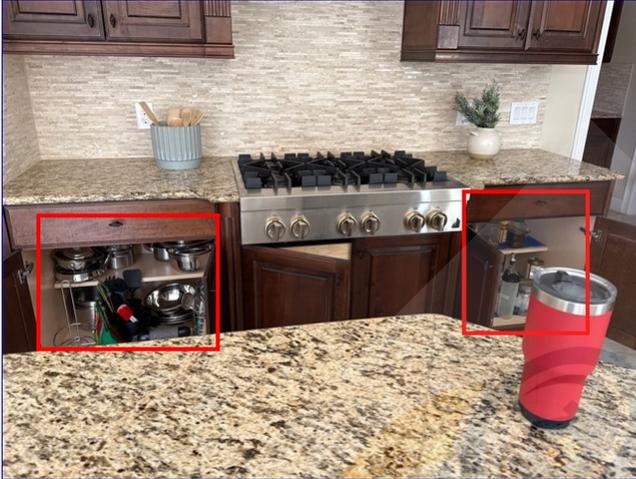
E. Item 1 (Picture) Cabinets around gas range

The appliance does not appear to have an easily accessible gas shutoff valve. This is not considered today's standard. I recommend having a qualified licensed plumbing contractor make repairs as needed.

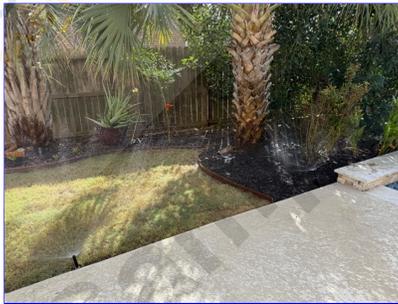
A. Item 16 (Picture) Tested

(3) There are two spray heads damaged. I recommend a qualified person to repair as needed.
