Inspection Report

Property Address:
5123 W

SoCal Master Home Inspection

Sample Report

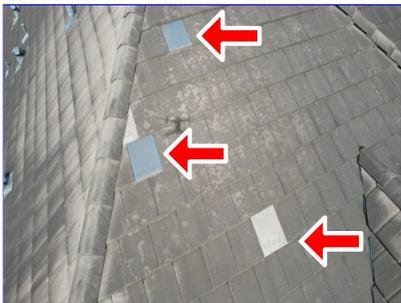
C. Item 1 (Picture) Roof line

(4) The roof shingles has been repaired at the front of home and rear of home. I recommend consulting with a roofing professional.

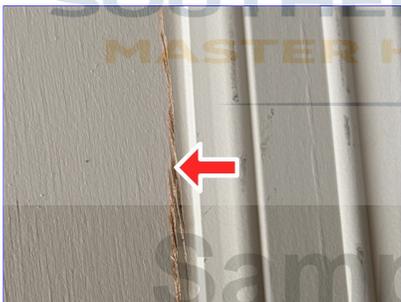
D. Item 1 (Picture) Attic opening at garage

(2) Attic opening cover& frame deteriorated. I recommend a qualified person to repair as needed.

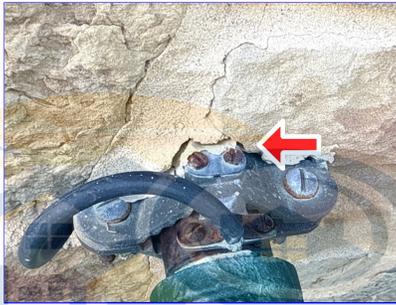
E. Item 7 (Picture) Multiple areas

(4) The Stucco coating exterior damaged and has hairline cracks. Further deterioration can occur if not corrected. A qualified stucco contractor should inspect and repair as needed.

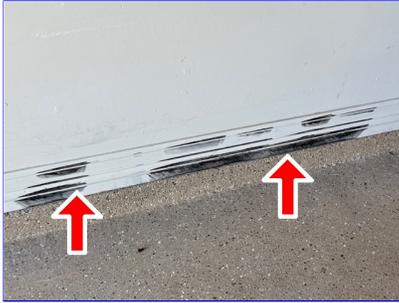
E. Item 12 (Picture) Baseboard in garage

(5) Interior trim is damaged or peeling paint in areas. This is a cosmetic issue. I recommend repair as desired.

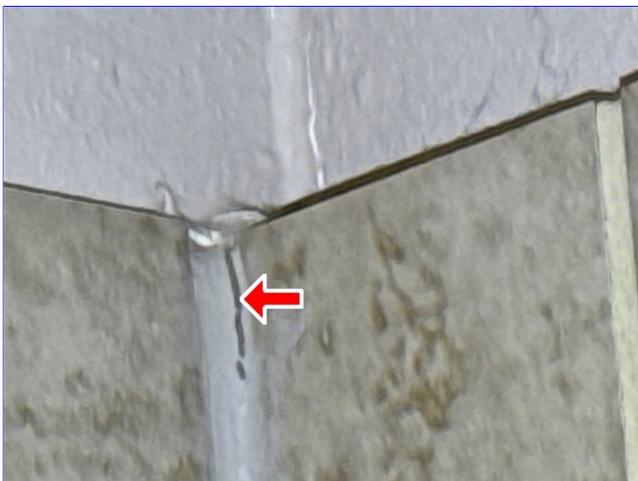
E. Item 22 (Picture) Right side hall bath

(7) The Tile surround at shower on the wall has cracking grout at the hall bath. Repairs are needed. A qualified person should repair or replace as needed.

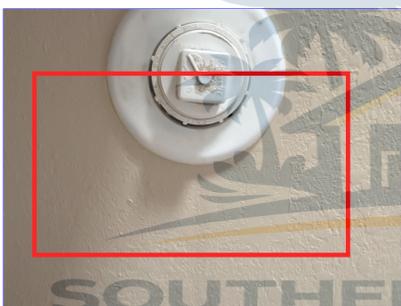
E. Item 23 (Picture) Laundry

(8) Drywall shows signs of repairs in areas. This is a cosmetic issue. I recommend having a qualified contractor inspect and repair as needed.

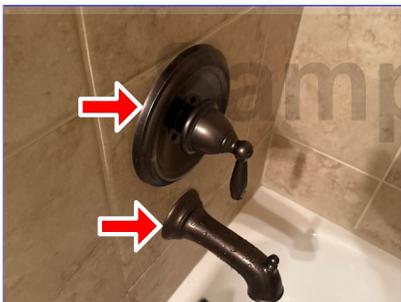
E. Item 25 (Picture) Bath at the 2nd floor

(9) The Surround kit for shower on the wall missing silicone caulking around control knob cover-plate/ shower head at the hall bath. Repairs are needed. A qualified person should repair or replace as needed.

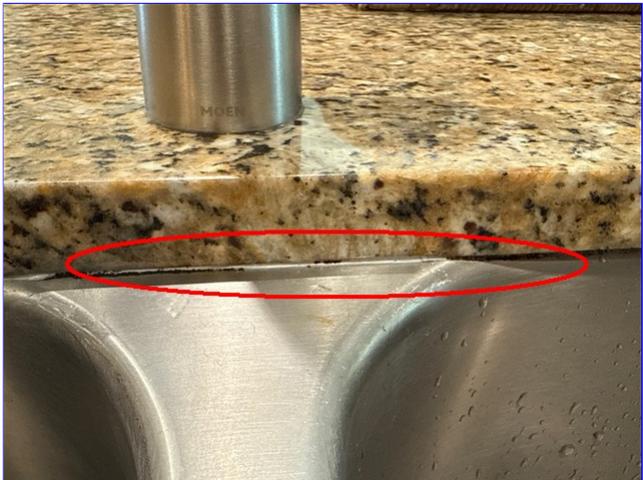
E. Item 27 (Picture) Kitchen sink

(10) Signs of fungi growth are present. We did not inspect, test or determine if this growth is or is not a health hazard. The underlying cause is moisture. I recommend you contact a mold inspector or expert for investigation or correction if needed.

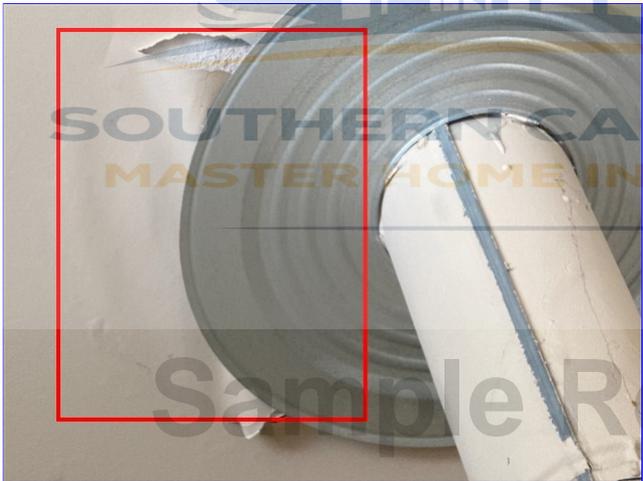
F. Item 1 (Picture) Garage at water heater area

(1) The Drywall on the ceiling is peeling in areas and needs prep and paint in areas. While this damage is cosmetic, it needs to be repaired. A qualified person should repair or replace as needed.

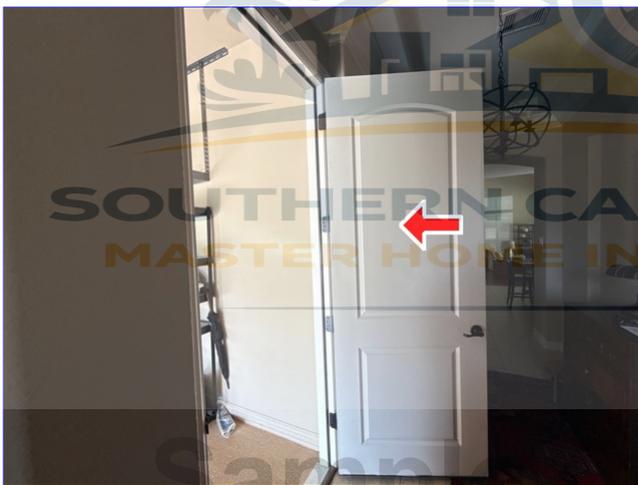
G. Item 1 (Picture) Interior garage door

(1) The interior garage door does not have the required self closing hinge. This is not considered to be today's standard. I recommend having a qualified person make repairs as needed.

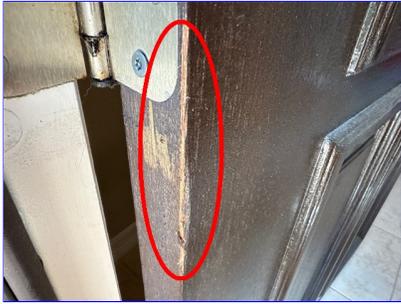
G. Item 2 (Picture) Front door

(2) The entry doors torn or peeling paint. This is a maintenance issue and is for your information. A qualified person should repair or replace as needed.

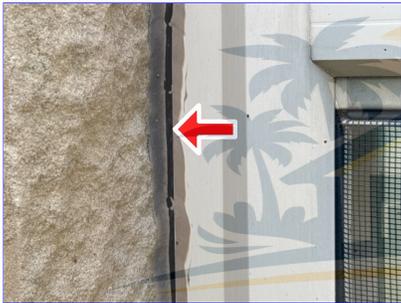
H. Item 1 (Picture) Front of home

(1) There are window frames that are not properly sealed. This can cause energy loss. I recommend having a qualified person seal and repair as needed.

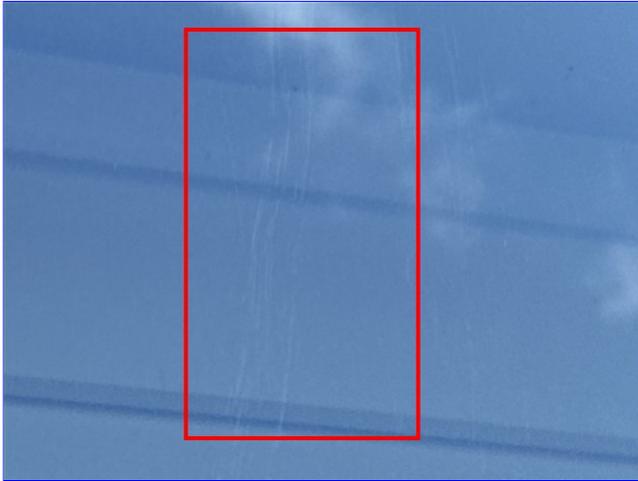
H. Item 5 (Picture) Rear of home

(2) The glazing between glass panes appear to be failing at some windows causing cloudy glass (If there are multiple windows that are the same age and style it is safe to assume others will soon start to fail as well). I recommend having a qualified person make repairs as needed.

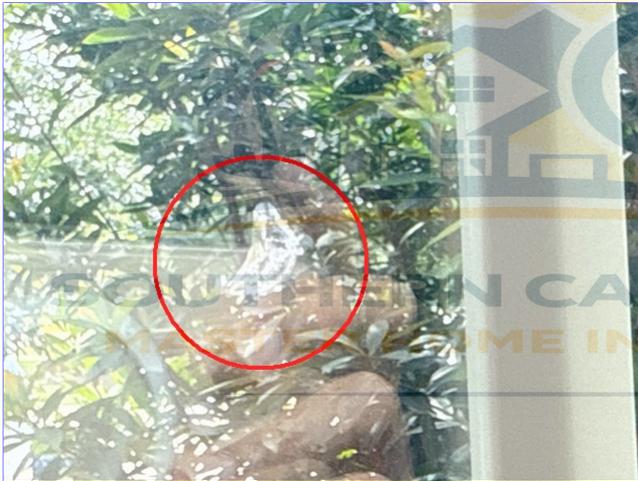
H. Item 6 (Picture) Front guest bedroom

(3) There is a damaged glass pane in window. I recommend having a qualified person make repairs as needed.

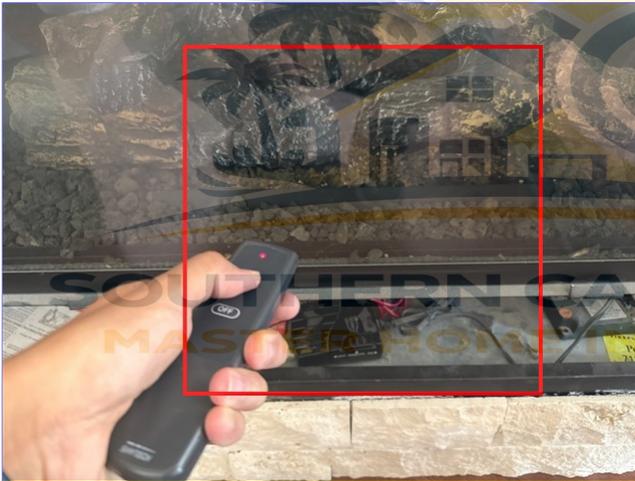
J. Item 2 (Picture) Not working

(3) Gas log fireplace would not lite by using remote control when tested. I recommend having sellers demonstrate.

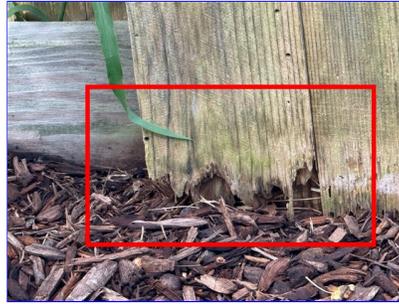
L. Item 9 (Picture) Multiple areas

(2) Fence is deteriorated/damaged in areas. Recommend repair or replace by a qualified contractor.

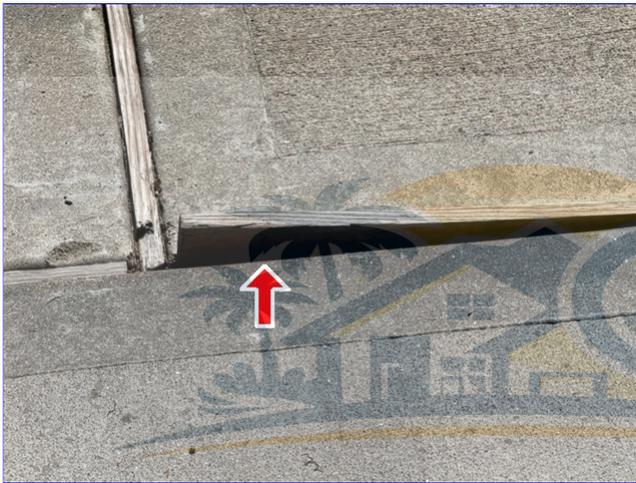
L. Item 10 (Picture) Driveway

(3) The wood trim loose at the driveway.

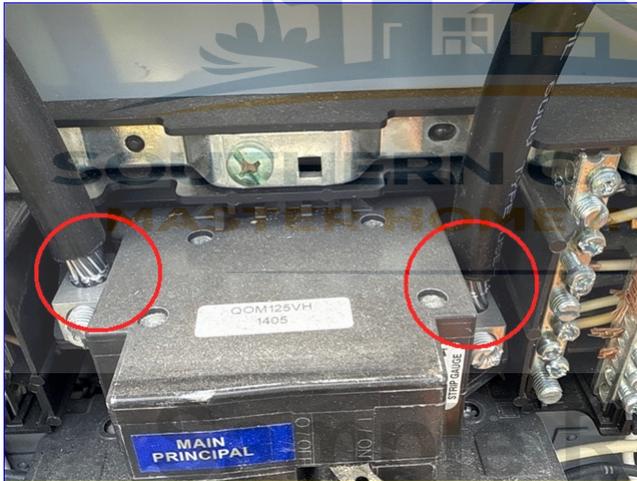
A. Item 1 (Picture) Main panel

(1) There is no antioxidant on aluminum conductors feeding panel. This is not considered to be today's standard. I recommend having a qualified electrician evaluate make repairs as needed.

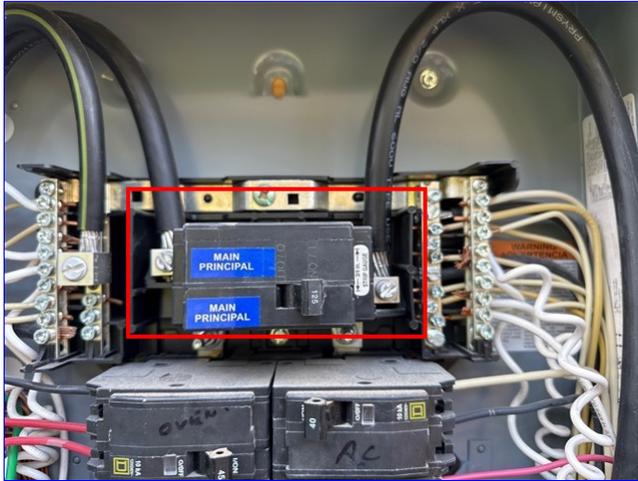
A. Item 2 (Picture) Main panel

(2) Lug covers were not installed at the service entrance wires. This is not considered today's standard.

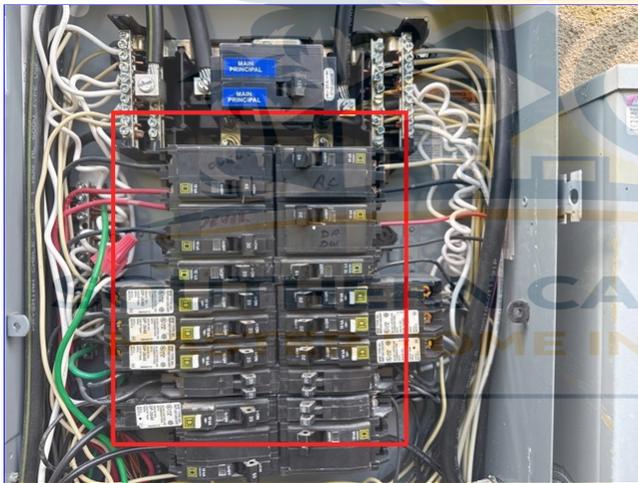
A. Item 3 (Picture) Main panel

(3) The main panel does not have a whole house surge protector. This is not today's standards. Recommend a licensed electrician to repair as needed.

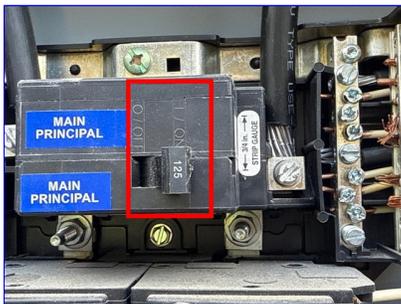
A. Item 4 (Picture) 125 amp main disconnect

(4) Service wiring does not appear to be the proper size for main disconnect in panel. This is safety issue. I recommend further evaluation by a qualified electrician.

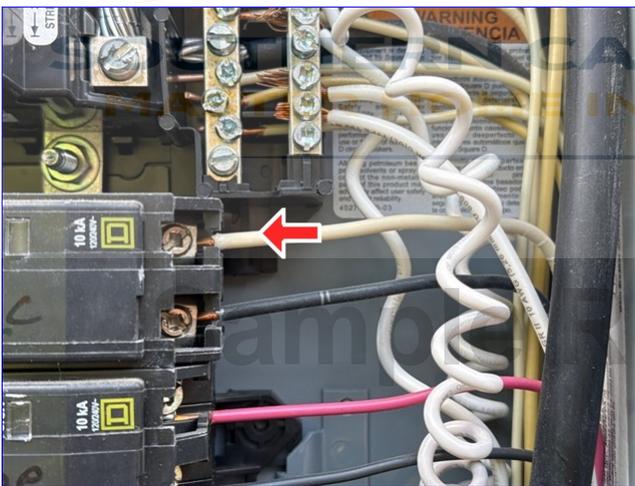
B. Item 3 (Picture) AC wires

- (3) Problem(s) discovered with Branch Circuits such as wire not labeled or identified and any other problems that an electrical contractor may discover while performing repairs need correcting. I recommend a licensed electrical contractor inspect further and correct as needed.

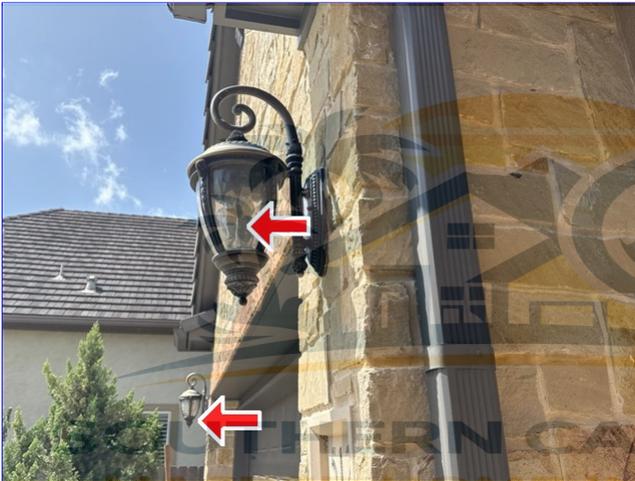
B. Item 6 (Picture) Front of garage

(5) The light fixture does not work (try bulb first). Electrical issues are considered a hazard until repaired. A qualified licensed electrical contractor should perform repairs that involve wiring.

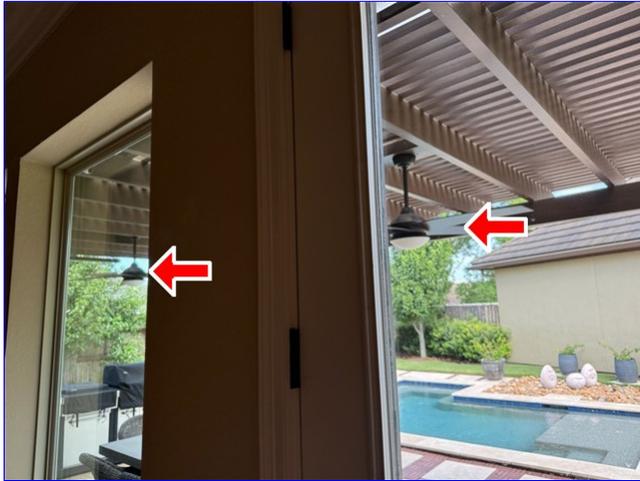
B. Item 14 (Picture) Patio area

(9) The ceiling fan does not work and in the patio area. This is for your information. I recommend repair as needed.

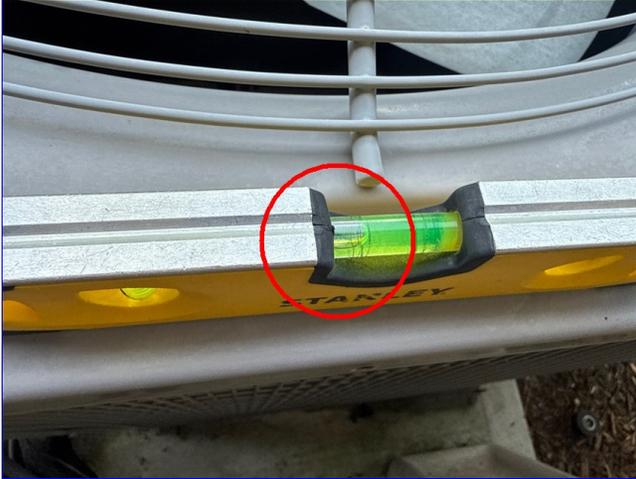
B. Item 1 (Picture) Rear of home

- (1) The condenser is not level. This can cause damage to the unit or shorten its life span. A licensed HVAC contractor should service or repair unit.

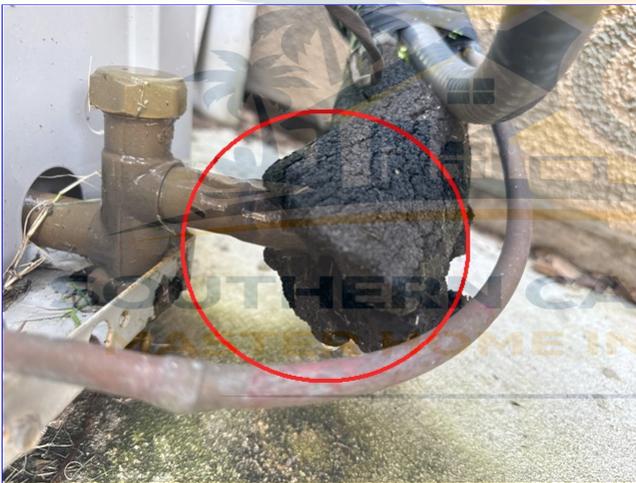
B. Item 2 (Picture) Rear of home

(2) The condenser is missing foam sleeve in area(s). A replacement is needed. A licensed HVAC contractor should service or repair unit.

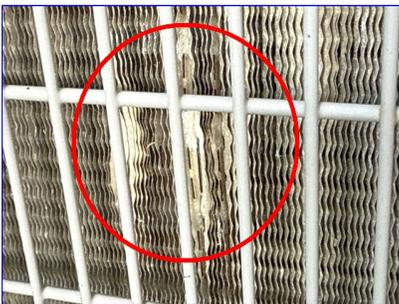
B. Item 3 (Picture) Condenser

(3) Condenser coil at exterior of home is damaged in areas. This damage can shorten the life expectancy of the unit. I recommend having a qualified HVAC company inspect and make repairs as needed.

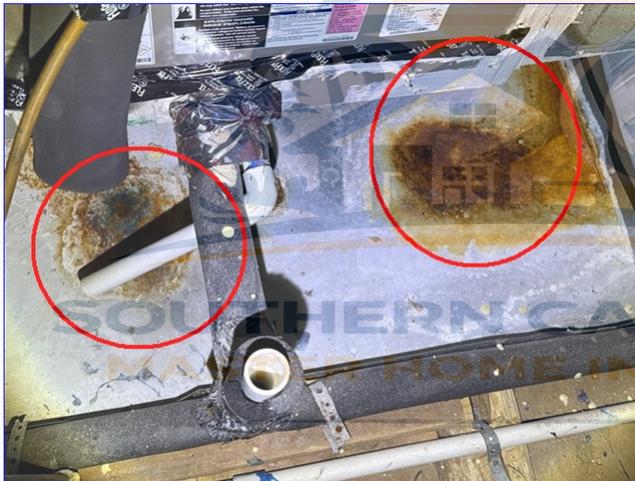
B. Item 7 (Picture) Attic

(5) The emergency overflow drain pan for the HVAC system is showing signs of deterioration. Further deterioration may occur if not corrected. I recommend having a qualified person make repairs as needed.

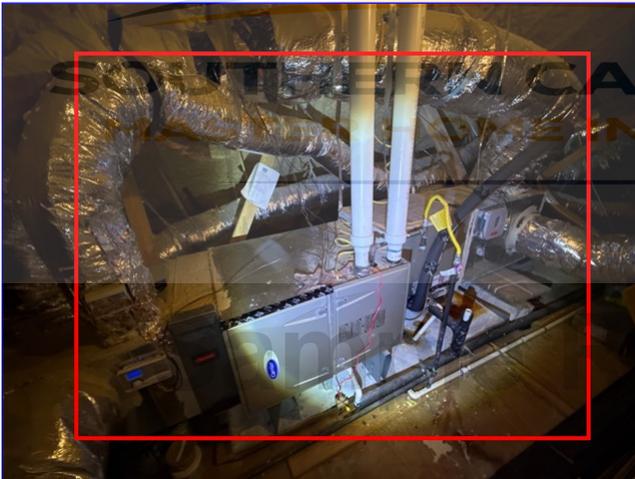
C. Item 5 (Picture) Attic

(3) The supply register is missing, the supply can help to control moisture and temperature in the attic . A replacement is needed. A licensed HVAC contractor should service or repair unit.

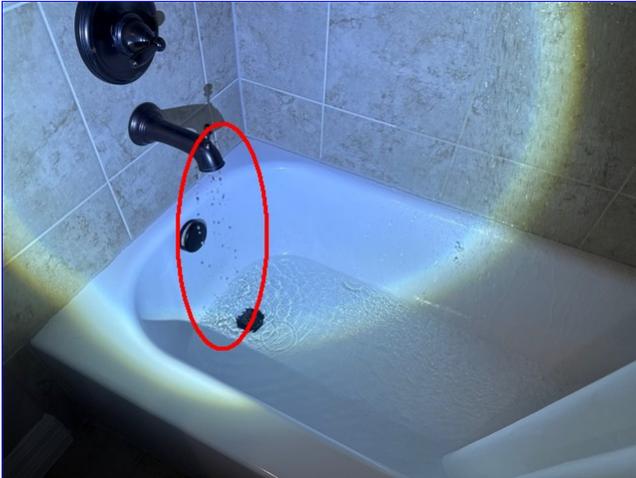
A. Item 3 (Picture) Bathroom at the 2nd floor gaming room

(4) Tub spout leaks when shower is in use. This is not considered today's standard. I recommend having a qualified person make repairs as needed.

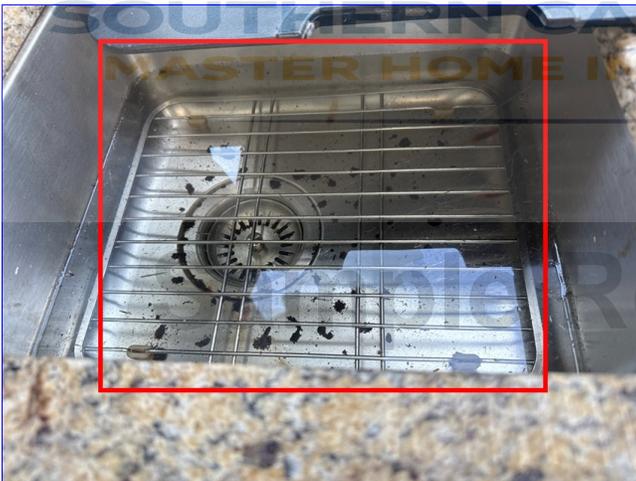
B. Item 1 (Picture) Outdoor kitchen

(2) The plumbing waste line is clogged at outdoor kitchen sink. Repairs are needed. A qualified licensed plumber should repair or correct as needed.

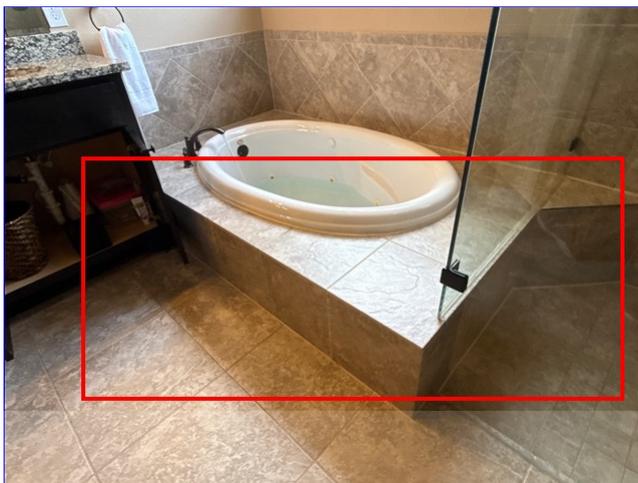
D. Item 1 (Picture) Master bath

(1) The jetted tub is missing access panel. I recommend adding access panel.

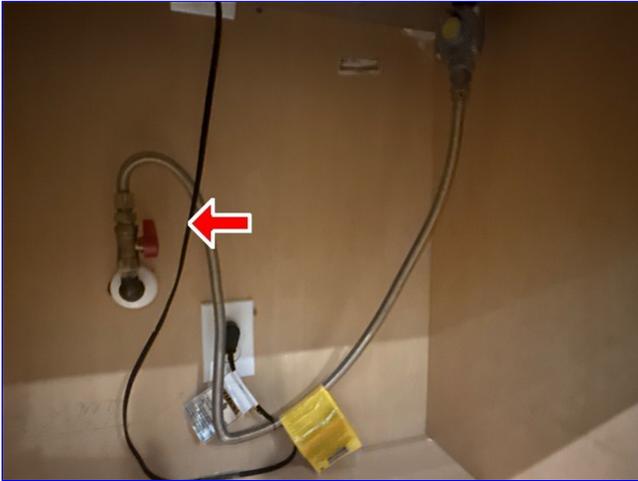
E. Item 1 (Picture) Multiple gas supplies

Home appears to have CSST piping. Unable to verify if piping is properly bonded. I recommend having a qualified electrician inspect and repair as needed.

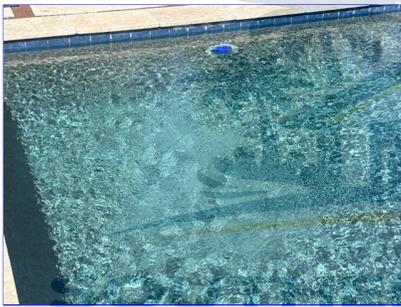
B. Item 4 (Picture) not turn off

(6) I did not find how to turn down the blower/ jets/ pump for the pool at the control station. I recommend the buyers get more info. from the owner.
