Inspection Report Sample #4

SOCAL MASTER HOME INSPECTION

PROPERTY INSPECTION REPORT FORM

I. STRUCTURAL SYSTEMS

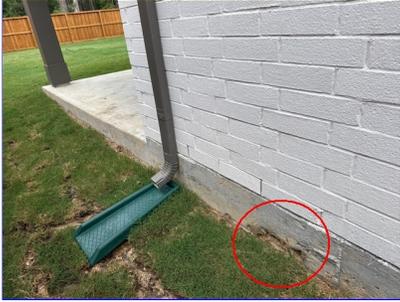
A. Item 1 (Picture) Left side of home

- (1) This is not an engineering report, but is only an opinion based on observation of conditions known to be related to foundation performance, using the knowledge and experience of the inspector.
- (2) The foundation wall appears to be showing signs of flaking and deterioration. I recommend having a qualified person make repairs as needed.

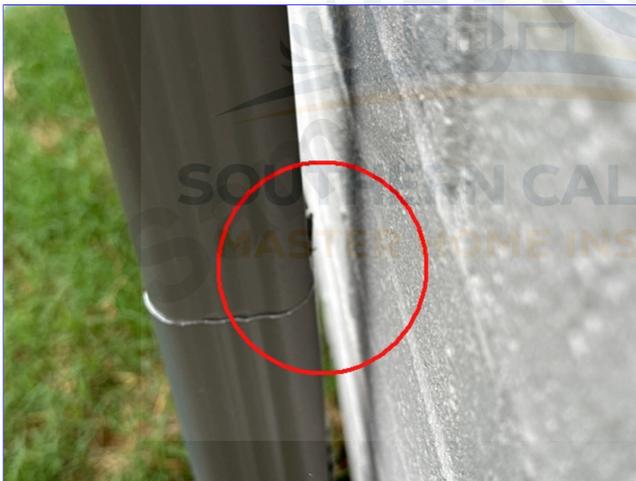
B. Item 3 (Picture) Rear of home(outside of master bedroom)

- (3) The downspout loose at the exterior. Erosion can continue or become worse if not corrected. A qualified person should repair or replace as needed.

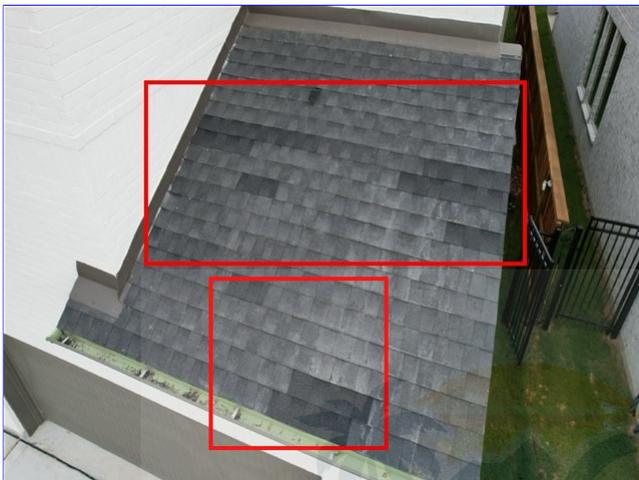
C. Item 1 (Picture) Right side front roof line

(4) The roof shingles has been repaired at the right side front of home. I recommend consulting with a roofing professional.

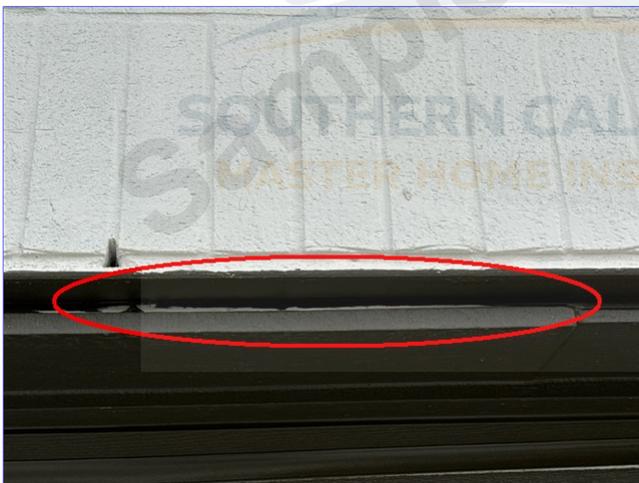
C. Item 2 (Picture) Front of garage

(5) Cap flashing installed improperly at the garage door area. I recommend a qualified person to repair as needed.

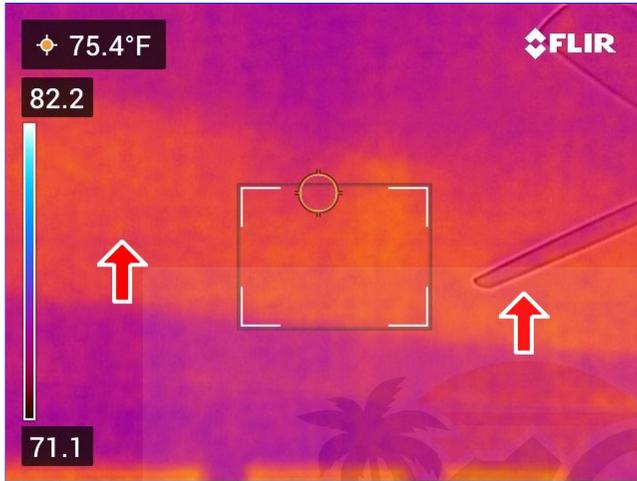
D. Item 1 (Picture) master bedroom

(2) The attic space is missing insulation at the master bedroom. This is causing energy loss and is not today's standard. I recommend having a qualified person evaluate and add insulation as needed.

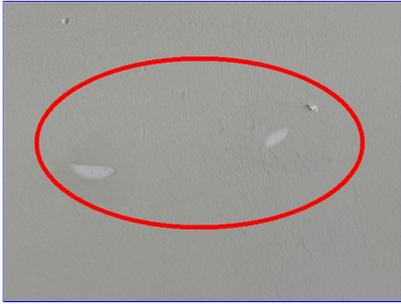
E. Item 4 (Picture) Garage in areas

(2) Drywall shows signs of repairs in areas. This is a cosmetic issue. I recommend having a qualified contractor inspect and repair as needed.

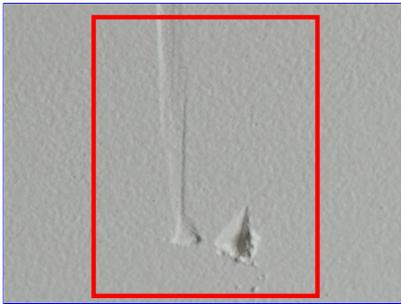
E. Item 9 (Picture) Garage

(3) The drywall on the wall is peeling paint/ deteriorated/ damaged. While this damage is cosmetic, it needs to be repaired. A qualified person should repair or replace as needed.

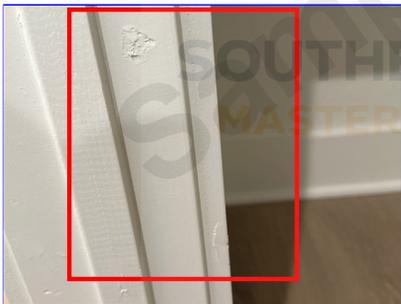
E. Item 13 (Picture) Pantry door jamb

(4) Interior trim is damaged or peeling paint in areas. This is a cosmetic issue. I recommend repair as desired.

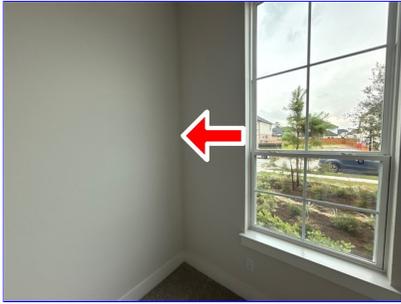
E. Item 22 (Picture) Multiple areas

(5) The paint on the drywall has several hairline cracks in areas. While this damage is cosmetic, it needs to be repaired. A qualified person should repair or replace as needed.

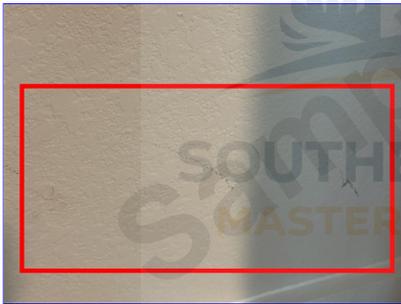
E. Item 26 (Picture) Master bedroom next to master bathroom door

(6) Drywall on the wall is dirty. I recommend clean as needed.

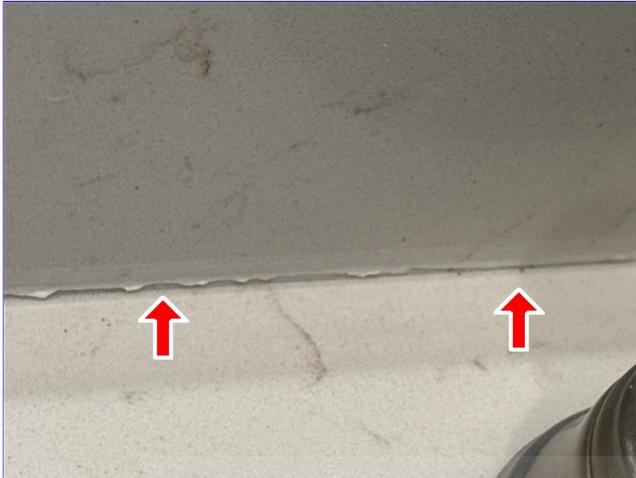
E. Item 28 (Picture) Master bathroom

(7) Bathroom back splash is not properly sealed at the counter top. I recommend repairs as needed.

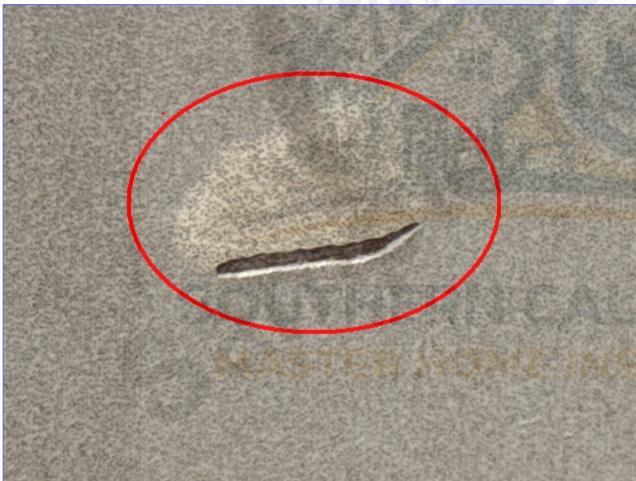
E. Item 29 (Picture) 2nd floor hall bath

(8) The tile on the wall is deteriorated at the Hall Bath. Repairs are needed. A qualified person should repair or replace as needed.

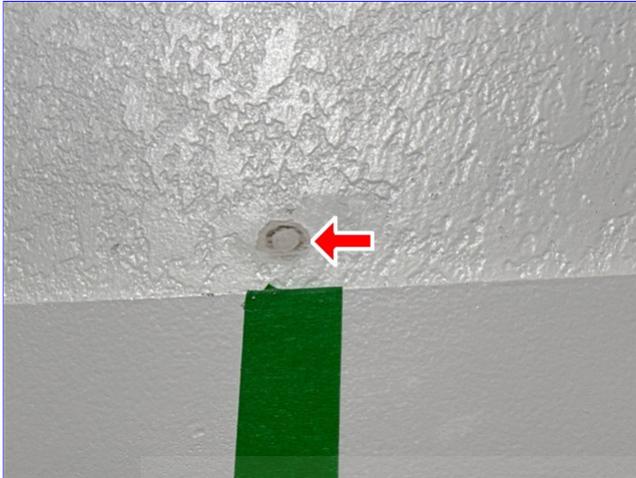
E. Item 30 (Picture) Right side front guest closet

(9) The drywall on the wall has some "nail pops," (cosmetic) at the closet. While this damage is cosmetic, it needs to be repaired. A qualified person should repair or replace as needed.

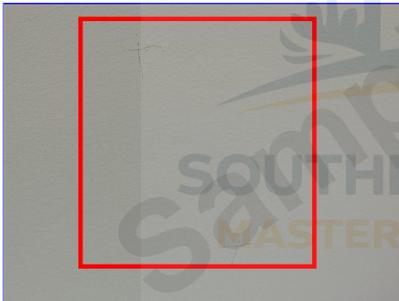
F. Item 1 (Picture) Master bedroom

(1) Drywall on the ceiling is dirty. I recommend clean as needed.

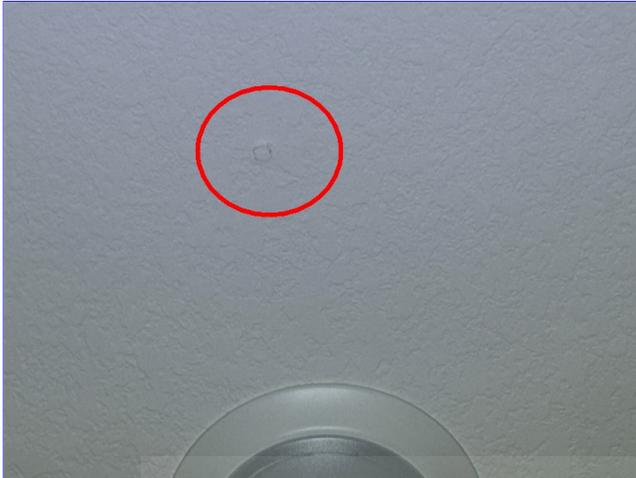
F. Item 3 (Picture) Master toilet room

(2) The Drywall on the ceiling has some "nail pops," (cosmetic). While this damage is cosmetic, it needs to be repaired. A qualified contractor should inspect and repair as needed.

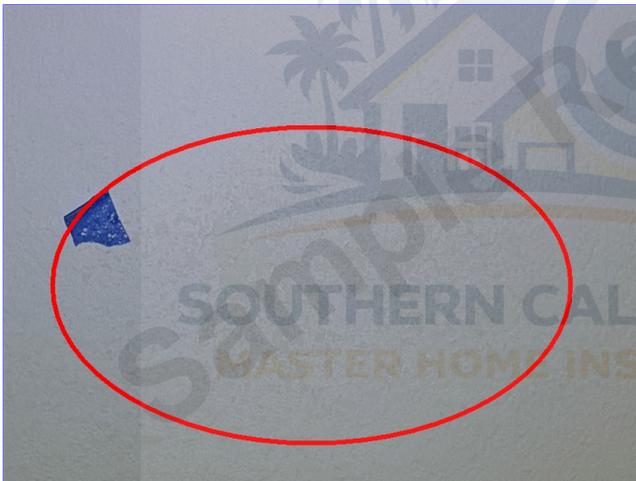
F. Item 4 (Picture) 2nd floor hall bath

(3) The Drywall on the ceiling shows repair signs at the Hall Bath. While this damage is cosmetic, it needs to be repaired. A qualified person should repair or replace as needed.

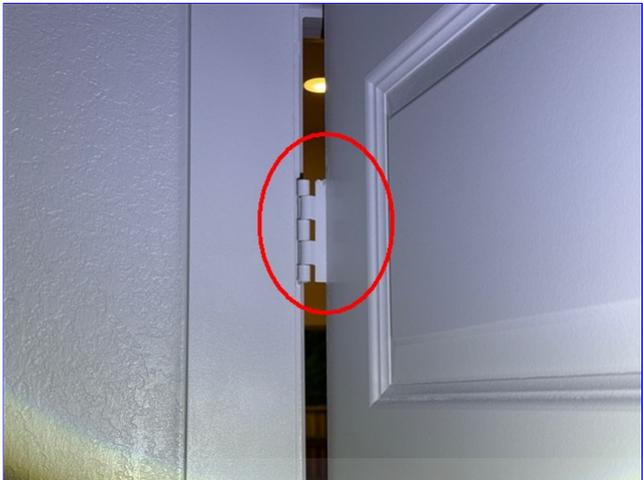
G. Item 1 (Picture) Master closet

Recommend installed door hinge stopper for master closet door.

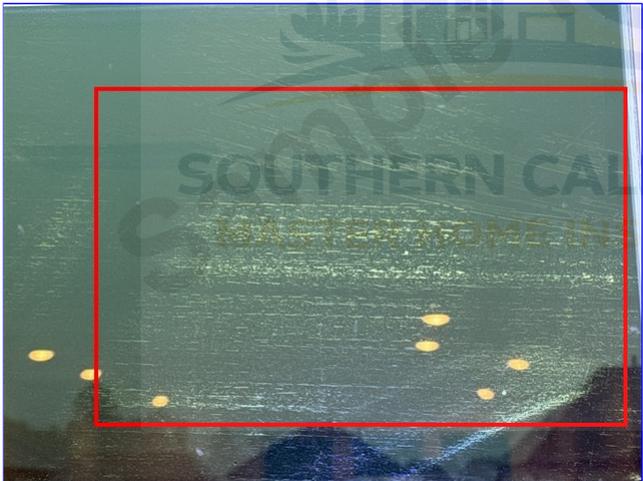
H. Item 1 (Picture) 2nd floor gaming room

Comments:
The glazing between glass panes appear to be failing at some windows causing cloudy glass (If there are multiple windows that are the same age and style it is safe to assume others will soon start to fail as well). I recommend having a qualified person make repairs as needed.

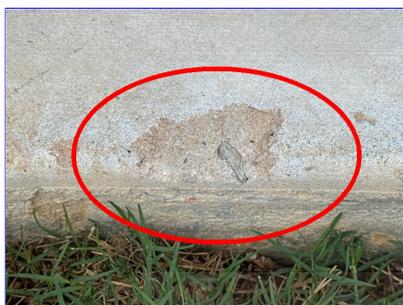
K. Item 1 (Picture) Edge of patio floor

- (1) The weight load capabilities are not part of this inspection.
- (2) The concrete floor on the covered patio at the rear of home deteriorated at the edge. Further deterioration can occur if not repaired. A qualified person should repair or replace as needed.

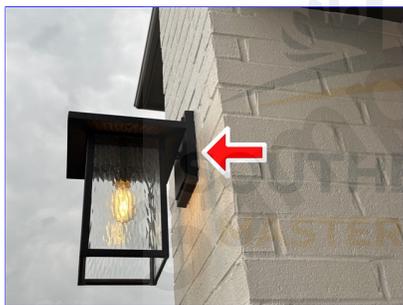
L. Item 1 (Picture) Fixture at the main entry area

- (1) Areas of the home have caulking or grout missing or damaged. Deterioration could occur if not corrected. I recommend having a qualified contractor inspect and make repairs as needed.

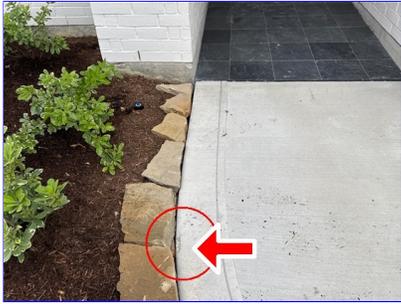
L. Item 5 (Picture) Front of main entrance

- (2) The concrete walkway at the front of home deteriorated in areas. Further deterioration can occur if not repaired. A qualified person should repair or replace as needed.

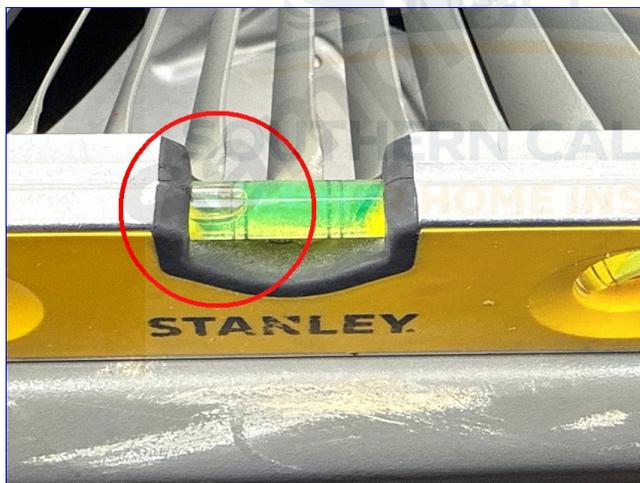
B. Item 1 (Picture) Right side of home

(1) The condenser is not level. This can cause damage to the unit or shorten its life span. A licensed HVAC contractor should service or repair unit.

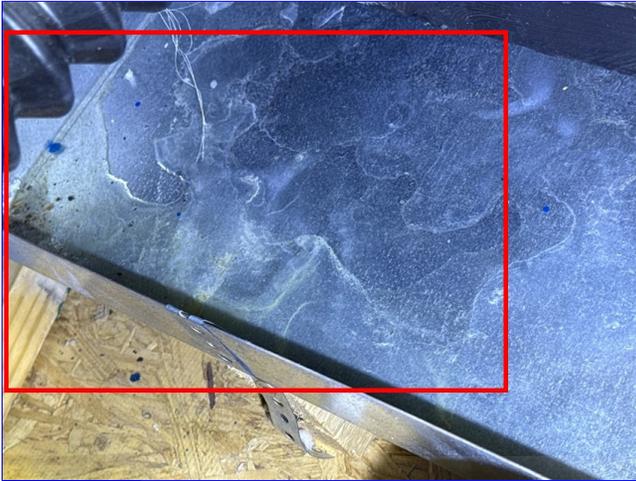
B. Item 2 (Picture) Attic

(2) The emergency overflow drain pan for the HVAC system full of condensation water. Further deterioration may occur if not corrected. I recommend having a qualified person make repairs as needed.

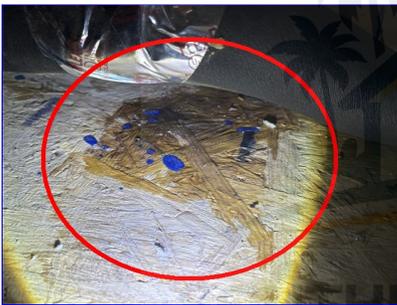
B. Item 3 (Picture) Condensation is happening

(3) Air leakage is happening at the air handler area. I recommend a qualified AC technician to inspect and repair as needed.

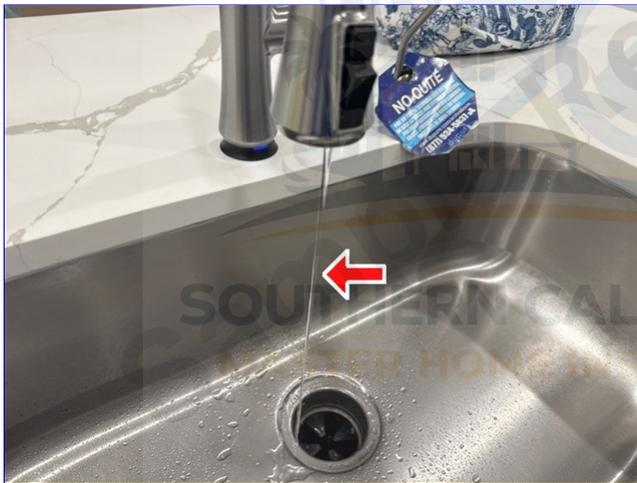
A. Item 2 (Picture) Kitchen

(3) Fixture has weak or restricted flow in areas. I recommend having a qualified plumber further evaluate and make any necessary repairs.

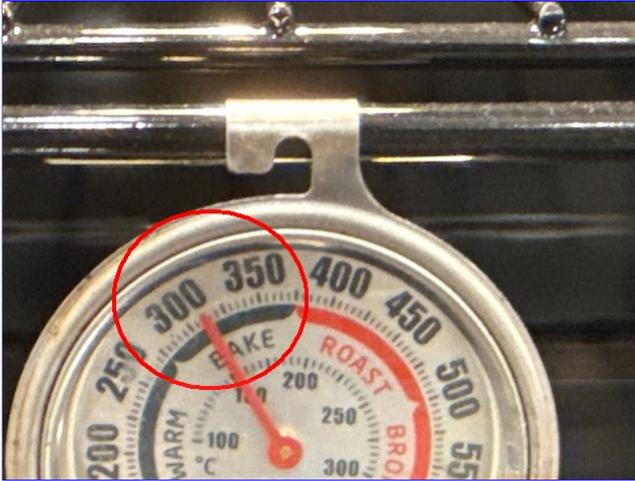
(1) Oven was tested and not working properly at time of inspection process. I recommend repairs as needed.

D. Item 1 (Picture) Setting temperature at 350F, the testing temperature should be between 325-375 F

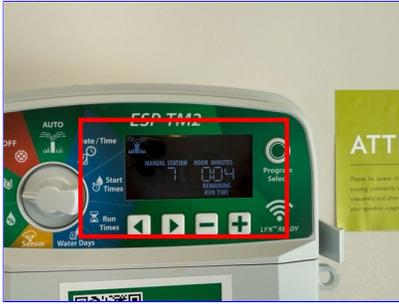
A. Item 12 (Picture) Setting zone “ on”

(2) Zone 7 may non- functional. I recommend the buyer get more information from the builder.

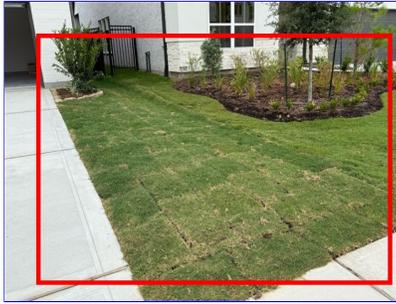
A. Item 13 (Picture) No spray heads come out

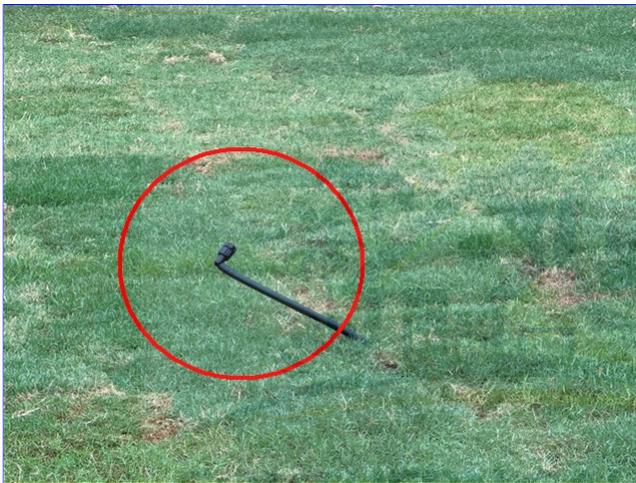
A. Item 14 (Picture) Backyard

(3) There is a spray head may disabled. I recommend buyer get more information from the builder.
