Framing Inspection Report Sample

SOCAL MASTER HOME INSPECTION

PROPERTY INSPECTION REPORT FORM

_____	5/15/2020
Name of Client	Date of Inspection
Address of Inspected Property	
Brian Siyuan Zheng	10365919
Name of Inspector	ICC License #
Name of Sponsor (if applicable)

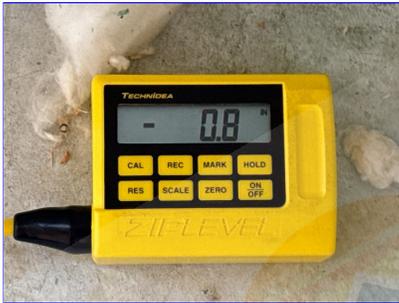
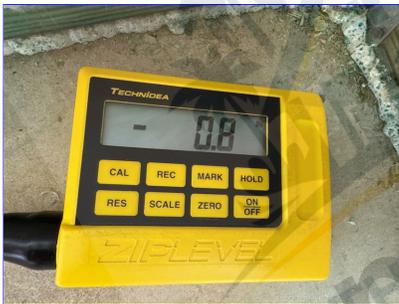
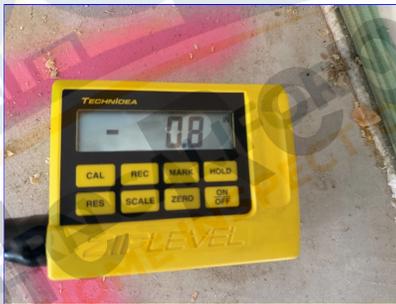
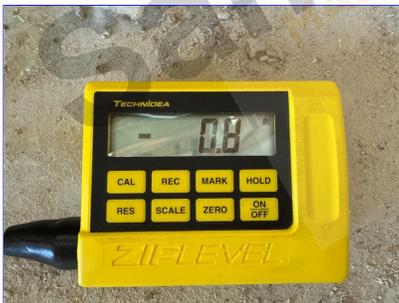
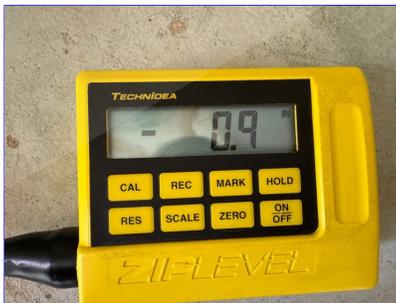
(2) The foundation is poured on grade with post tension cables and appears to be performing as designed.

A. Item 1 (Picture) Front left corner

A. Item 2 (Picture) Middle left side of home

A. Item 3 (Picture) Rear left corner

A. Item 4 (Picture) Front right corner

A. Item 5 (Picture) Middle right side of home

A. Item 6 (Picture) Rear right corner

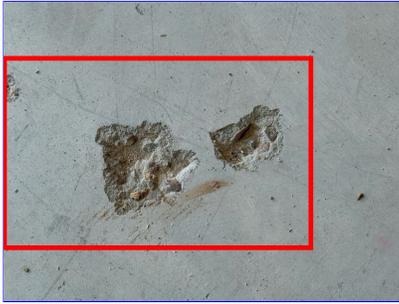
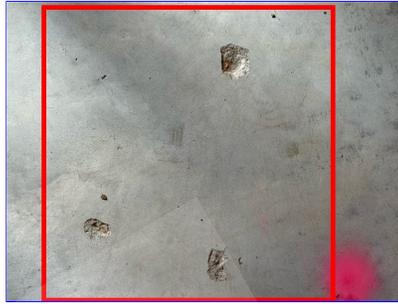
(3) Foundation floor deteriorated at the surface. I recommend a qualified person to repair as needed.

A. Item 7 (Picture) Multiple areas

A. Item 8 (Picture) Multiple areas

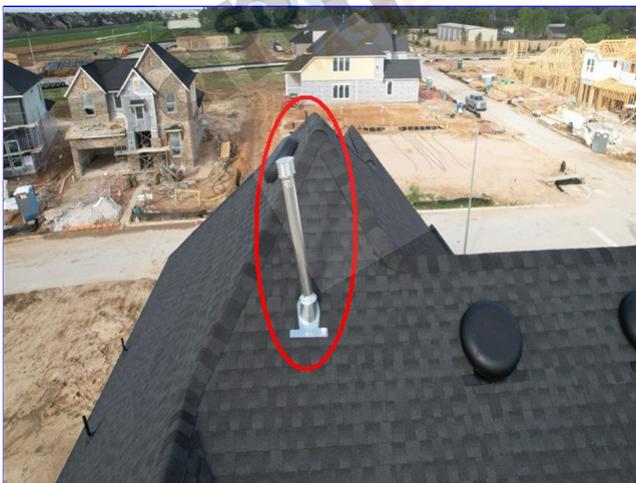
C. Item 1 (Picture) Roof line

- (1) This inspection does not warrant against roof leaks.
- (2) The flashing is not clearly visible and I am unable to verify proper installation and condition. I recommend consulting with a roofing professional to evaluate and make any necessary repairs.
- (3) The lowest eave of the roof line of the home is not accessible using a 17 foot ladder (the tallest ladder that can be safely moved and or climbed solo). All efforts were made to safely inspect the roofing surface using binoculars and/or aerial photography equipment. This limited the inspection to areas that were safely accessible and or visible at the time of inspection.
- (4) The exhaust venting boot is leaning. I recommend a qualified person to repair as needed.

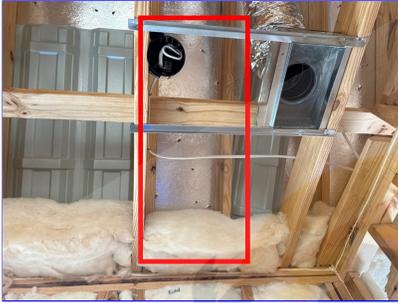
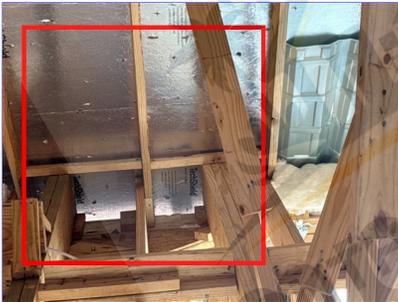
(2) Baffle is missing. I recommend a qualified person to repair as needed.

D. Item 1 (Picture) Right side front guest bedroom

D. Item 2 (Picture) 2nd floor front guest bedroom

D. Item 3 (Picture) Multiple areas

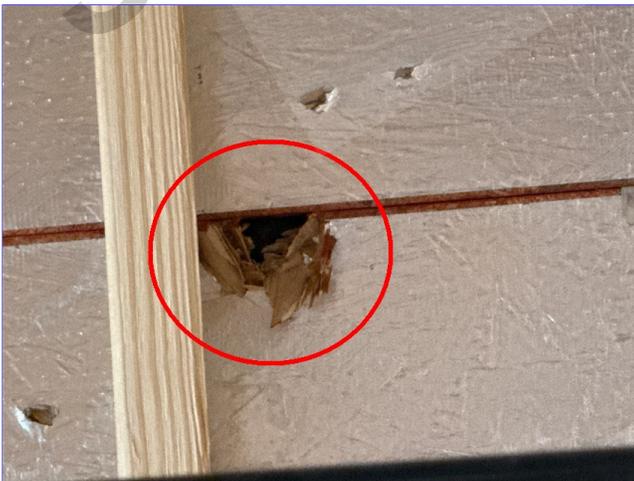
D. Item 4 (Picture) Rear of home

(3) Wooden sheathing panel damaged. I recommend a qualified person to repair as needed.

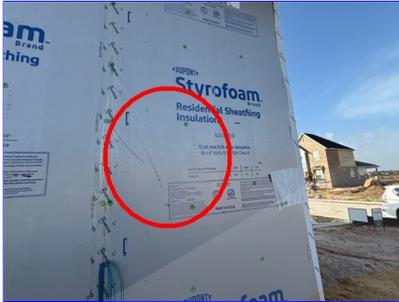
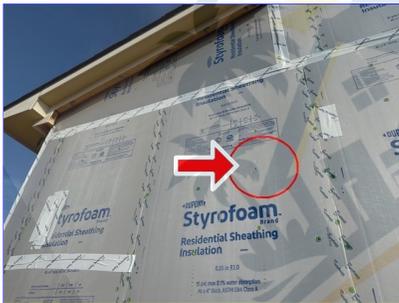
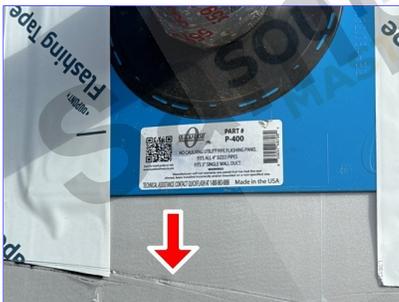
(1) The sheathing insulation board deteriorated at the surface. I recommend a qualified person to repair as needed.

E. Item 1 (Picture) Left side of home

E. Item 2 (Picture) Left side of home

E. Item 3 (Picture) Right side of home

E. Item 4 (Picture) Right side of home

E. Item 5 (Picture) Right side of home

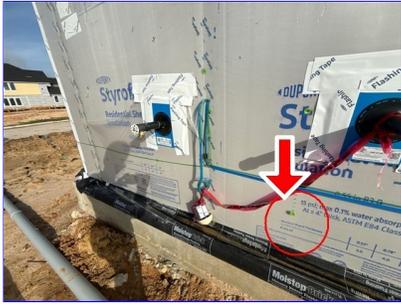
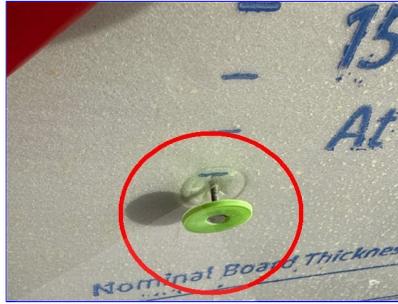
(2) Secure screw for sheathing insulation panel loose. I recommend a qualified person to repair as needed.

E. Item 6 (Picture) Right side of home

E. Item 7 (Picture) Right side of home

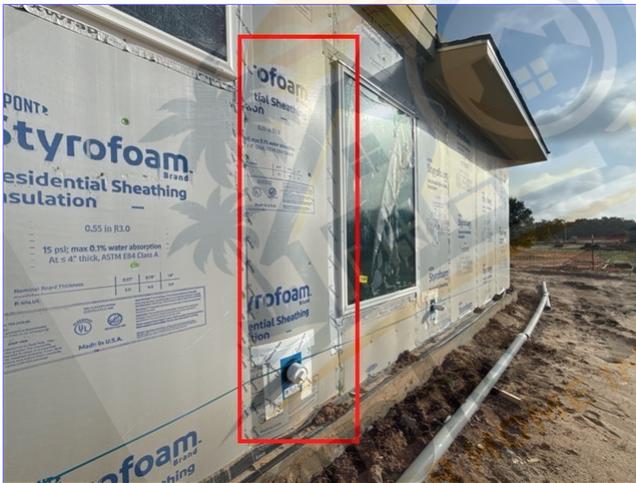
E. Item 8 (Picture) Right side of home

(3) The sheathing insulation panel bowed on the wall. I recommend a qualified contractor to inspect and repair as needed.

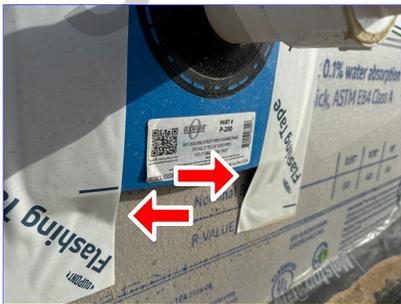
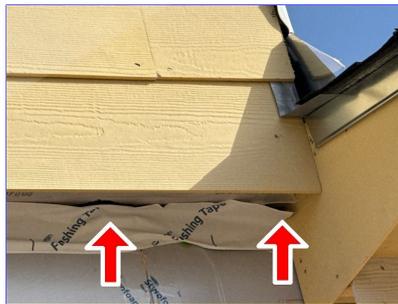
(4) Flashing tape does not seal down. I recommend a qualified person to inspect as needed.

E. Item 9 (Picture) Right side of home

E. Item 10 (Picture) Right side of home

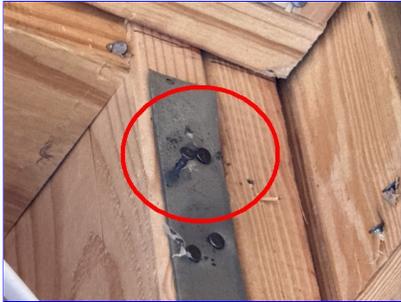
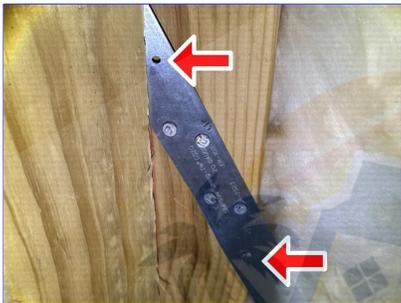
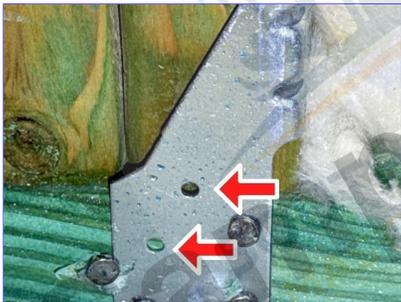
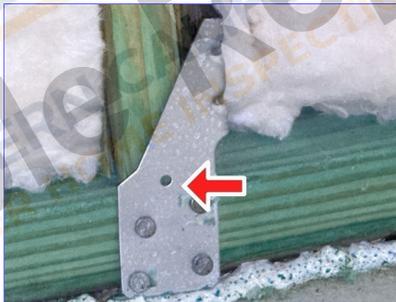
(5) Nails loose/ missing at the ties. I recommend a qualified person to repair as needed.

E. Item 11 (Picture) Right side of garage

E. Item 12 (Picture) Left side of garage

E. Item 13 (Picture) Right side of stairway

E. Item 14 (Picture) Patio area

E. Item 15 (Picture) multiple areas

E. Item 16 (Picture) multiple areas

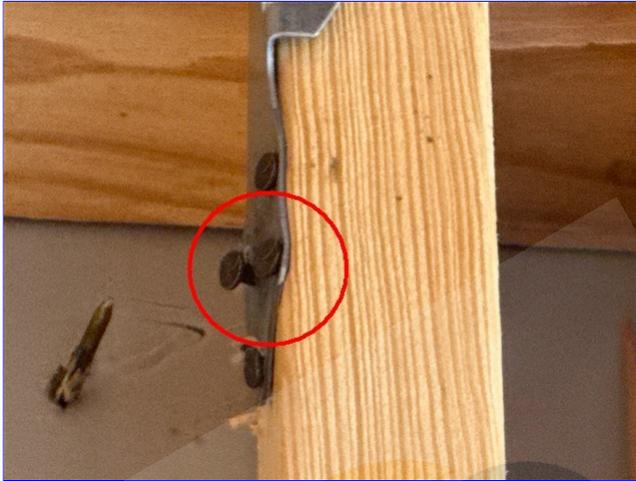
E. Item 17 (Picture) Rear left side of garage

(6) Secure screws loose at the hurricane ties. I recommend a qualified person to repair as needed.

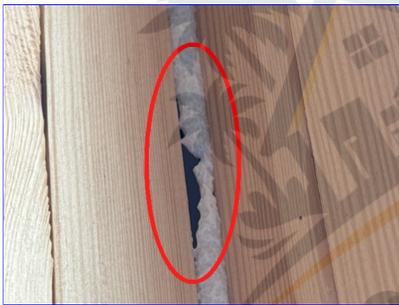
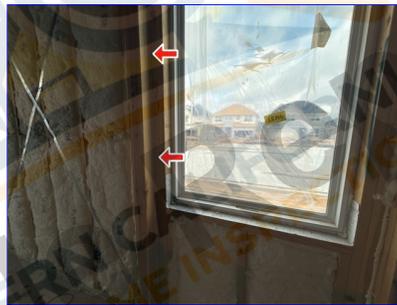
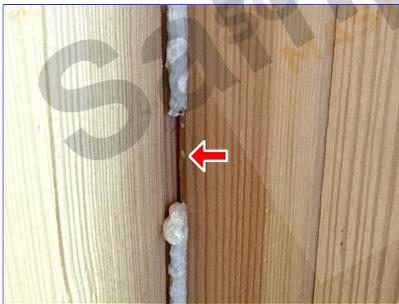
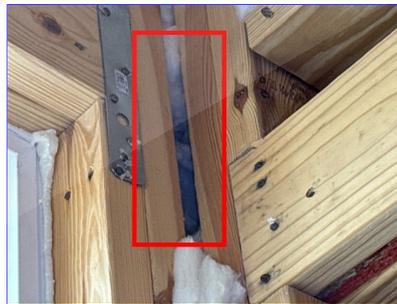
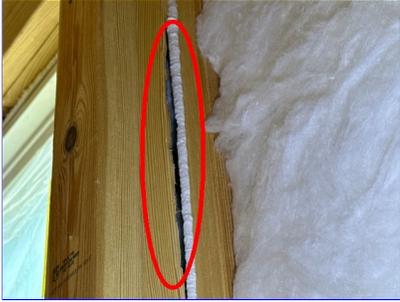
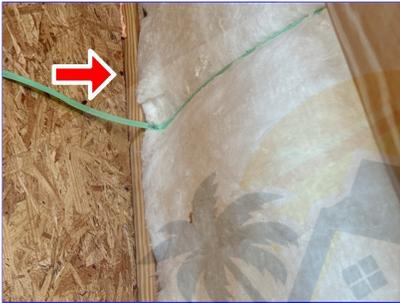
(7) Fire blocking foam does not install continuously. I recommend a qualified person to repair as needed.

E. Item 18 (Picture) Left side of home

E. Item 19 (Picture) Left side of home

E. Item 20 (Picture) Left side of home

E. Item 21 (Picture) Left side of home

E. Item 22 (Picture) Left side of home

E. Item 23 (Picture) Multiple areas

E. Item 24 (Picture) Stairway area

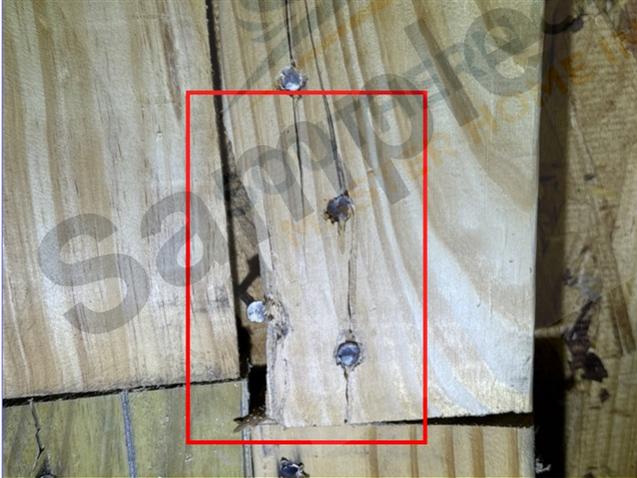
E. Item 25 (Picture) Under stairway

(8) The wooden stud damaged. I recommend a qualified person to repair as needed.

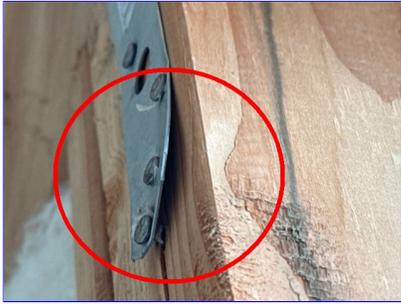
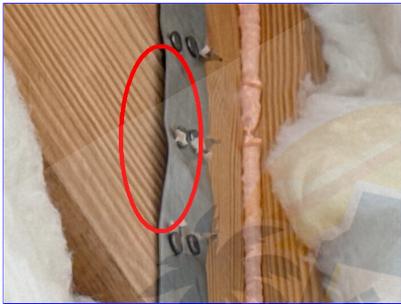
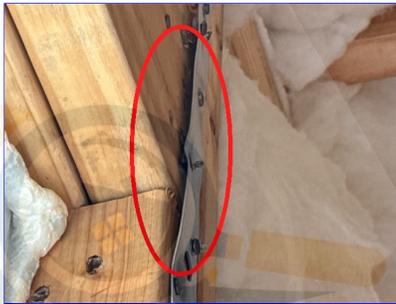
(9) Tie plate dented. I recommend a qualified person to repair as needed.

E. Item 26 (Picture) Rear of home

E. Item 27 (Picture) Rear of home

E. Item 28 (Picture) Rear of home

E. Item 29 (Picture) 2nd floor rear bedroom

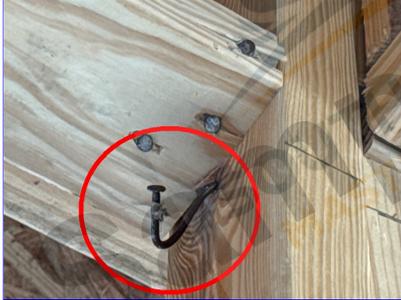
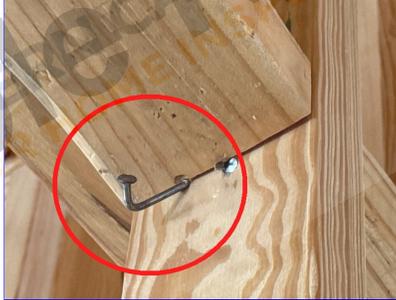
(10) The nail loose at the trim. I recommend a qualified person to repair as needed.

E. Item 30 (Picture) Rear of home

E. Item 31 (Picture) Front of garage

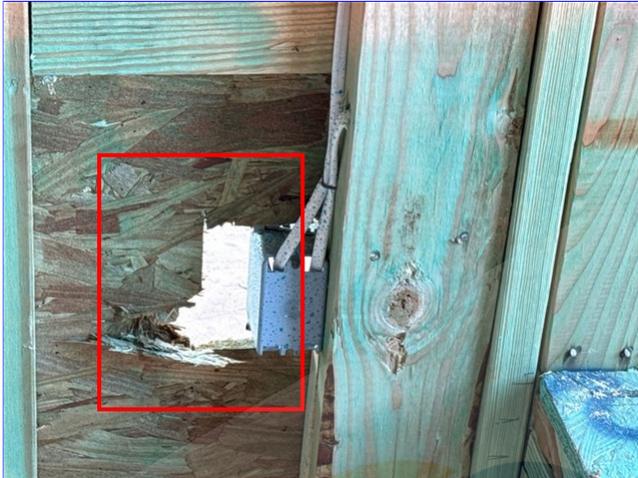
E. Item 32 (Picture) Master bathroom

(11) The wood panel damaged. I recommend a qualified person to repair as needed.

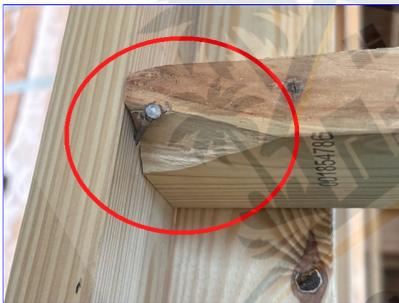
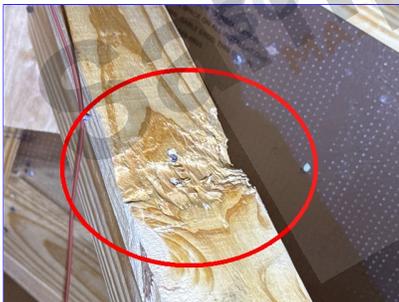
(12) Wood trim damaged. I recommend a qualified person to repair as needed.

E. Item 33 (Picture) Right side of home(laundry area)

E. Item 34 (Picture) 2nd floor guest closet

E. Item 35 (Picture) Attic at the opening area

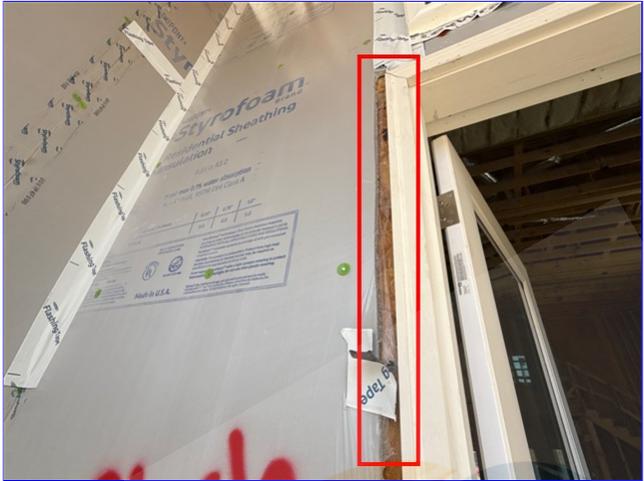
E. Item 36 (Picture) Back door area

(13) Sheathing insulation panel is missing at the patio area. I recommend a qualified person to repair as needed.

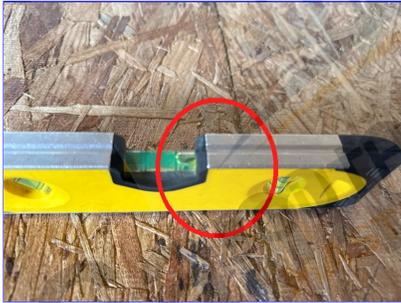
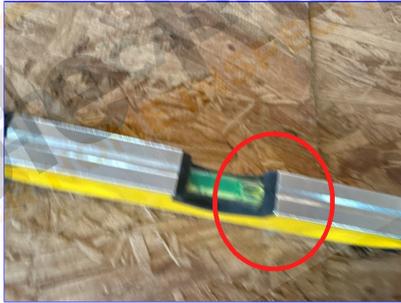
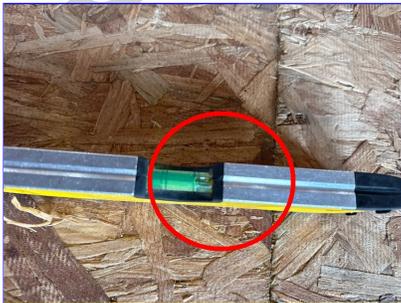
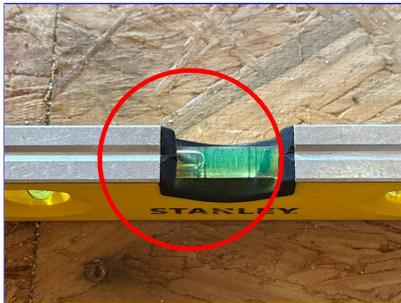
Sub floor covering is non- leveled. I recommend a qualified person to repair as needed.

F. Item 1 (Picture) 2nd floor

F. Item 2 (Picture) 2nd floor

F. Item 3 (Picture) Multiple areas

F. Item 4 (Picture) Multiple areas

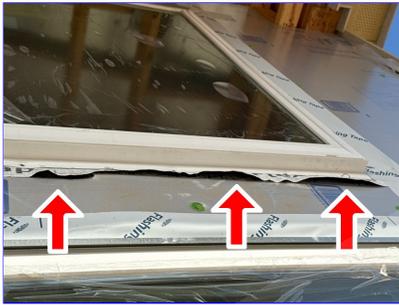
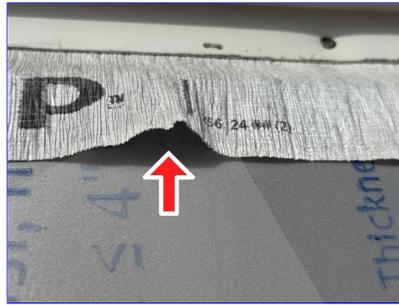
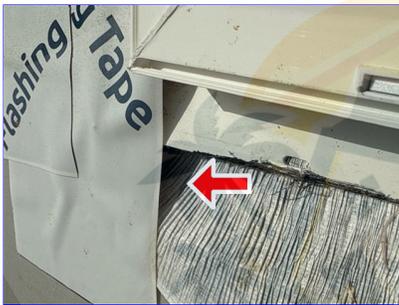
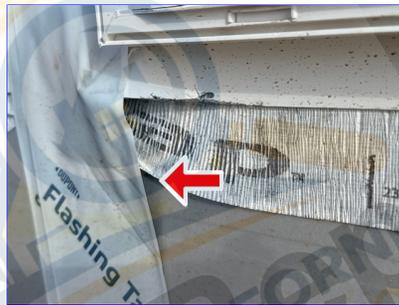
(1) The flashing tapes do not seal probably. I recommend a qualified person to repair as needed.

H. Item 1 (Picture) Patio area

H. Item 2 (Picture) Patio area

H. Item 3 (Picture) Patio area

H. Item 4 (Picture) Right side of home

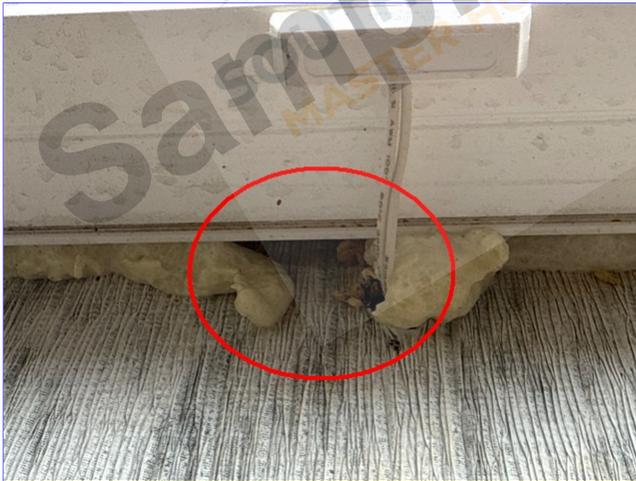
H. Item 5 (Picture) Rear of home

(2) Insulation is missing. I recommend a qualified person to repair as needed.

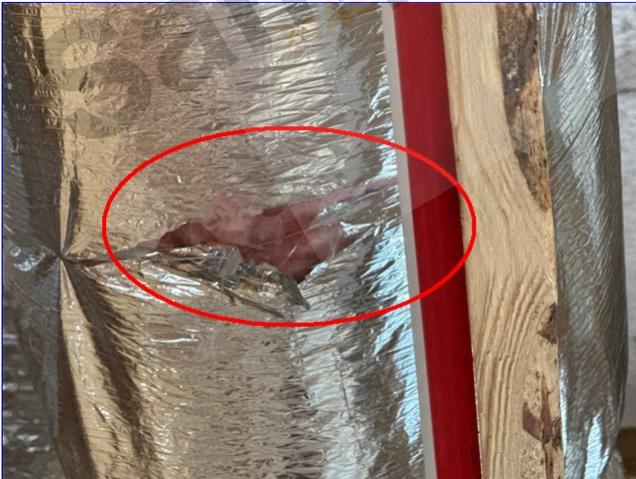
C. Item 1 (Picture) Rear bedroom

(2) Costing for duct pipe damaged. I recommend a qualified person to repair as needed.

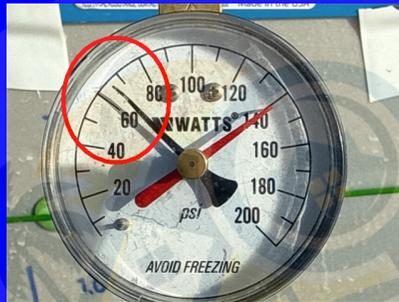
Water pressure, 67 psi

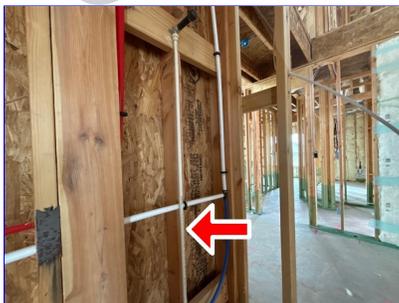
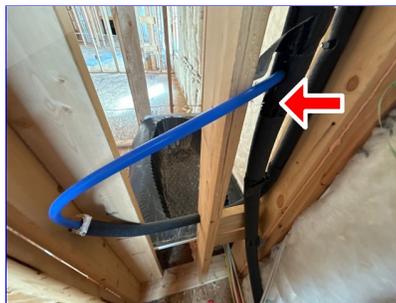
(2) Plumbing pipe loose. I recommend a qualified person to repair as needed.

A. Item 1 (Picture) 1st floor suite at the shower area

A. Item 2 (Picture) 2nd floor right side front private bath

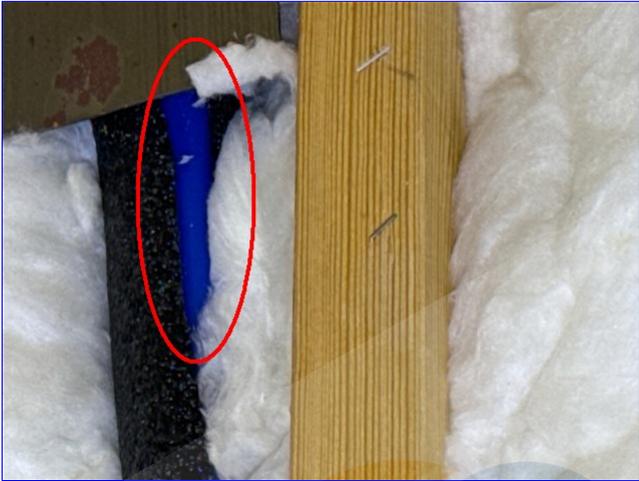
A. Item 3 (Picture) Rear of home

(3) Supply line is not properly insulated in areas. I recommend having a qualified plumber inspect and repair as needed.

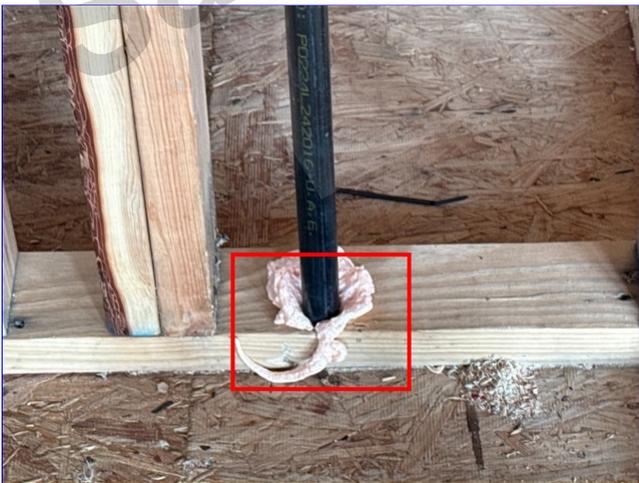
E. Item 1 (Picture) 2nd floor middle right side of guest bedroom

(1) Gas pipe is missing protective plate. I recommend a qualified person to repair as needed.

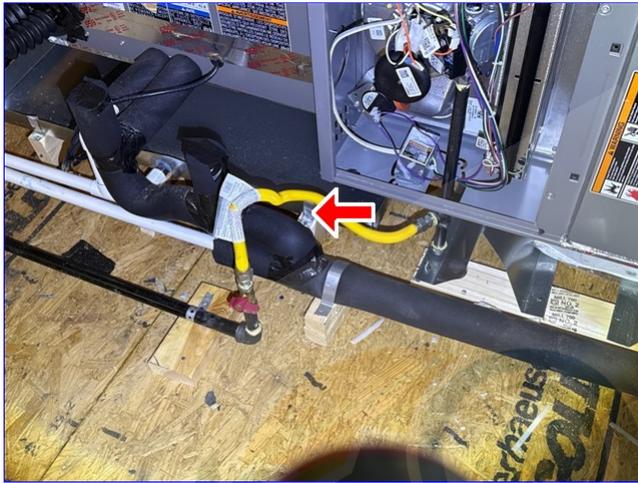
E. Item 2 (Picture) Gas supply

(2) Home appears to have CSST piping. Unable to verify if piping is properly bonded. I recommend having a qualified electrician inspect and repair as needed.
