SOUTHERN CALIFORNIA
MASTER HOME INSPECTION

Inspection Report Sample#3

PROPERTY INSPECTION REPORT FORM

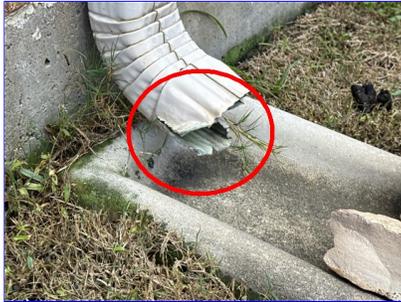
B. Item 2 (Picture) Multiple areas

The downspout is damaged. Further deterioration can occur. I recommend having a qualified person make repairs as needed.

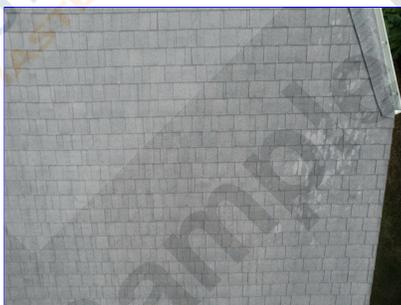
C. Item 2 (Picture) "whole" roof surface

- (4) The roof shingles are showing wear and granular loss (Granules provide UV protection for shingles. Once the granules erode away, the sun is able to deteriorate the asphalt and shorten the life of the roof covering). Further deterioration can occur. I recommend having a qualified roofing contractor further evaluate and make repairs or replace as needed.

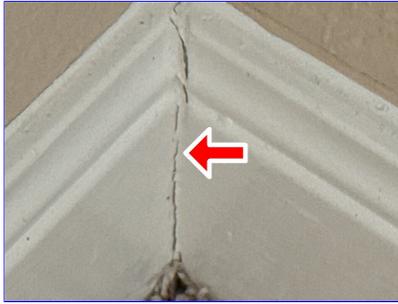
E. Item 5 (Picture) Baseboard in multiple areas

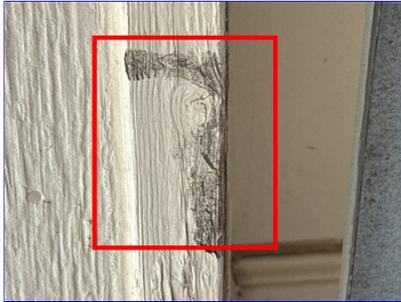
E. Item 12 (Picture) Garage door jamb

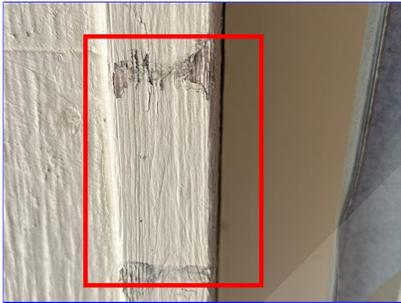
E. Item 13 (Picture) Garage door jamb

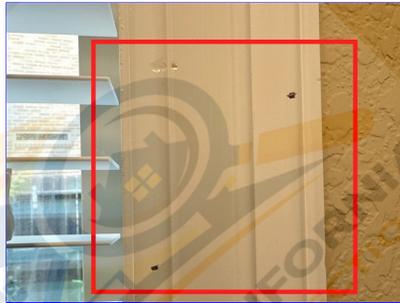
E. Item 19 (Picture) Window frames

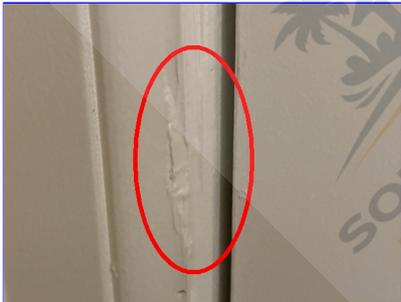
E. Item 20 (Picture) Multiple door jambs

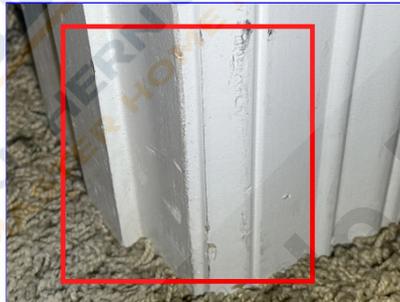
E. Item 21 (Picture) Multiple door jambs

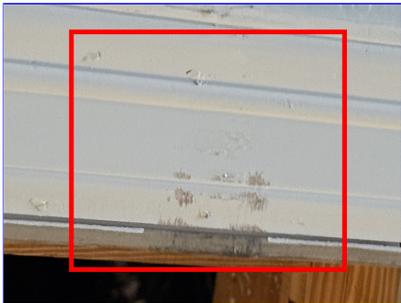
E. Item 22 (Picture) Attic opening

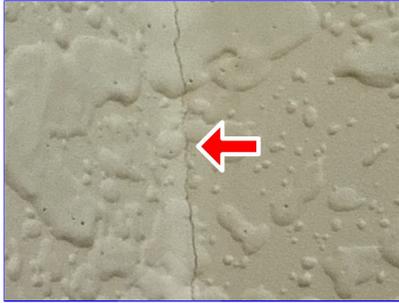
E. Item 24 (Picture) Drywall at the corner

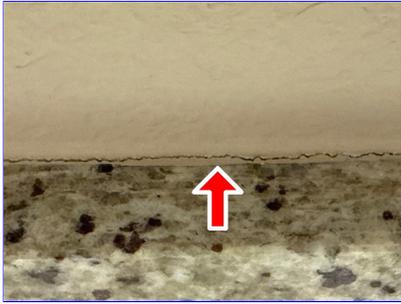
E. Item 26 (Picture) 1st floor guest private bath

(9) The sealant on the backsplash at the countertops is deteriorated or missing. Water intrusion and deterioration can occur. I recommend having a qualified person make repairs as needed.

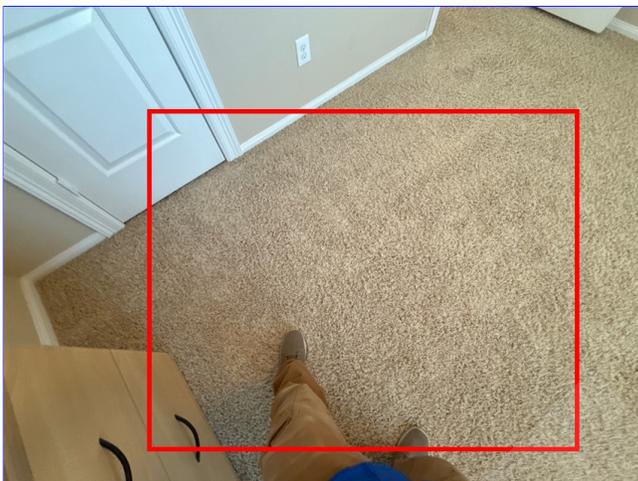
F. Item 2 (Picture) 2nd floor in multiple areas

(2) The sub-floor squeaks in areas (nuisance only). This is considered cosmetic. I recommend having a qualified professional make repairs as needed.

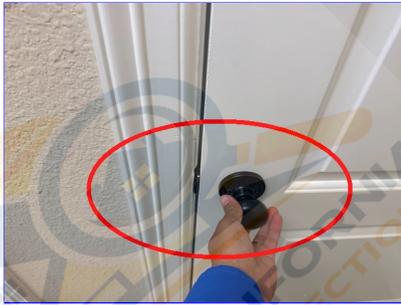
G. Item 5 (Picture) Laundry

(3) The door does not lock properly and should be adjusted. Further deterioration can occur. I recommend having a qualified professional make repairs or replace as needed.

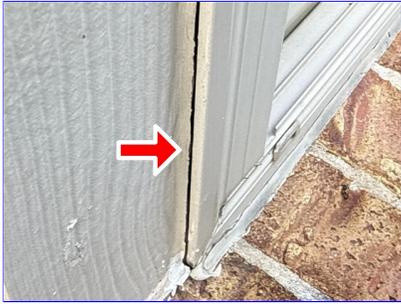
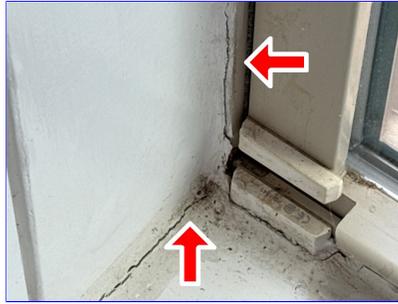
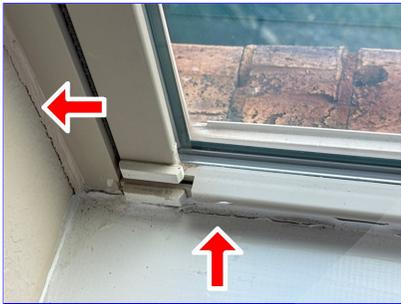
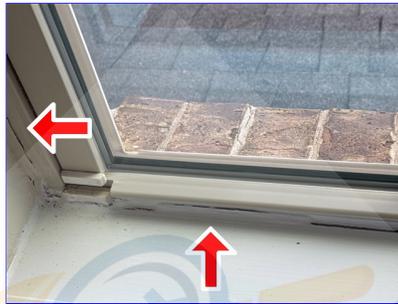
(3) There are window frames that are not properly sealed. This can cause energy loss, water intrusion and deterioration. I recommend having a qualified person make repairs as needed.

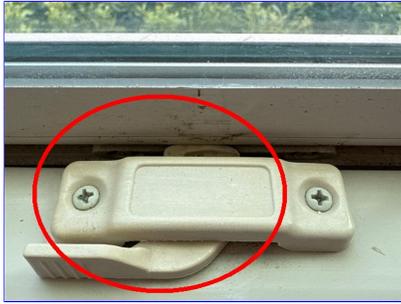
H. Item 11 (Picture) 1st floor guest bedroom

(4) Some windows are not locking properly. This is a maintenance issue and is for your information. I recommend having a qualified person make repairs as needed.

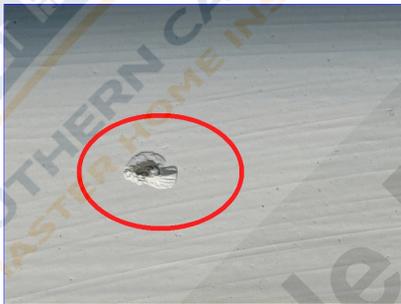
H. Item 15 (Picture) Dining room

(5) Window sills deteriorated on the surface. I recommend a qualified person to repair as needed.

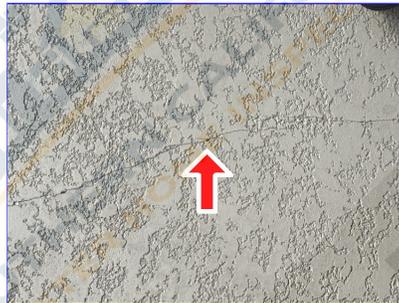
K. Item 2 (Picture) Patio floor

- (1) The weight load capabilities are not part of this inspection.
- (2) The concrete floor on the patio has cracked in some areas (which are cosmetic). Further deterioration can occur if not repaired. I recommend having a qualified person make repairs as needed.

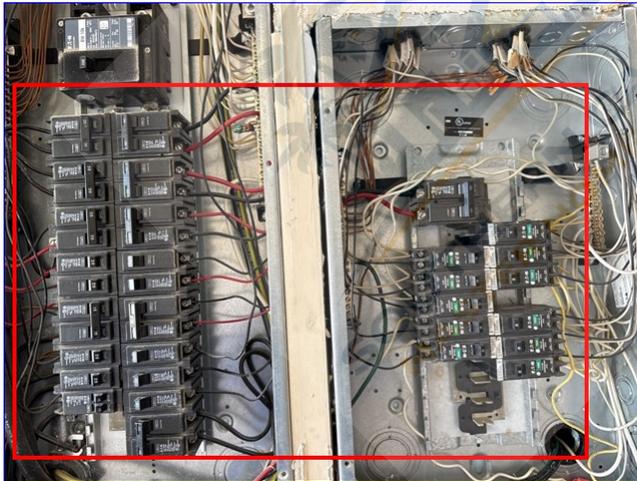
A. Item 1 (Picture) Main panel

(1) The main panel does not have a whole-house surge protector. This is not considered today's standards.

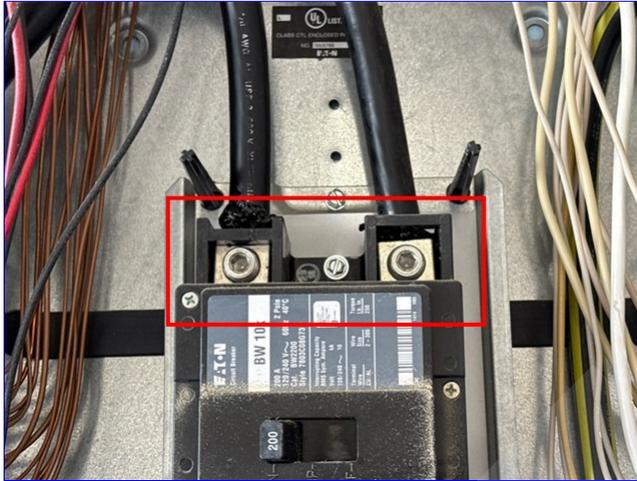
A. Item 2 (Picture) Main panel

(2) Lug covers were not installed on the service wires' lugs. This is not considered today's standard.

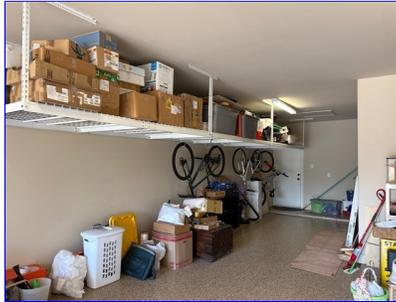
B. Item 3 (Picture) Garage

(3) The light fixture is missing globe. This is for your information. I recommend having a qualified person make repairs as needed.

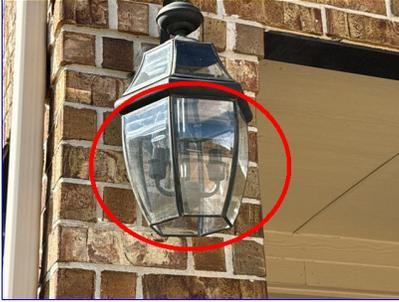
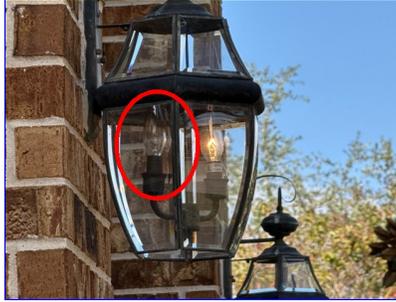
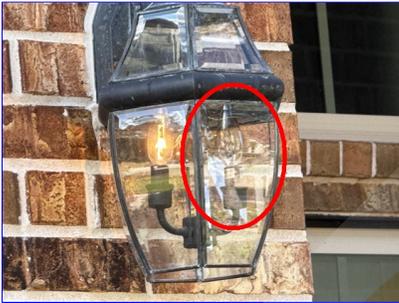
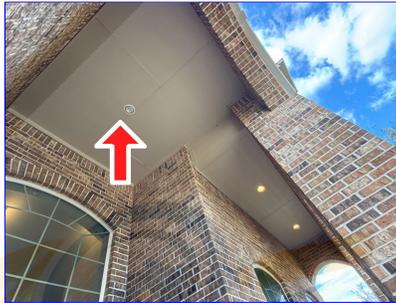
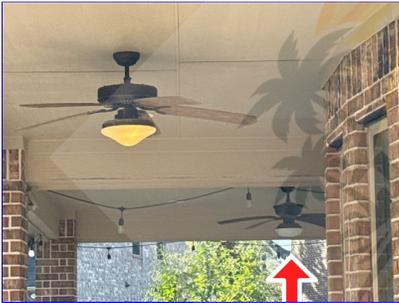
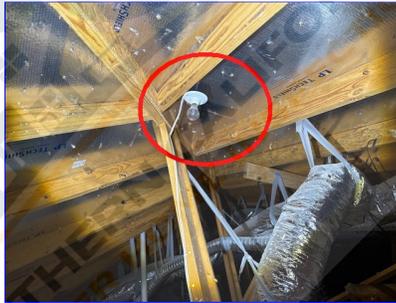
(4) The light fixture did not work (try bulb first). Electrical issues are considered a hazard until repaired. A qualified licensed electrical contractor should perform repairs that involve wiring.

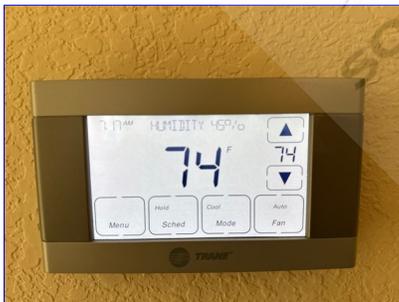
B. Item 3 (Picture) 2nd floor arrive

- (1) It is recommended to have the HVAC systems serviced annually.
- (2) Thermostat Location(s), arrival and departure setting.

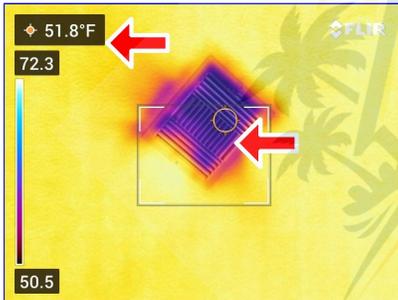
B. Item 6 (Picture) 1st floor cooling supply

(4) The ambient air test was performed by using infrared thermal equipment at the supply vents of both Air conditioners to determine if the difference in temperatures of the supply and return air is between 15 degrees and 22 degrees, which indicates that the unit is cooling as intended. The supply air temperature on your system read 51.8/ 54 .3 degrees, and the return air temperature was 68.9/ 72.9 degrees. This indicates that the range in temperature drop is normal.

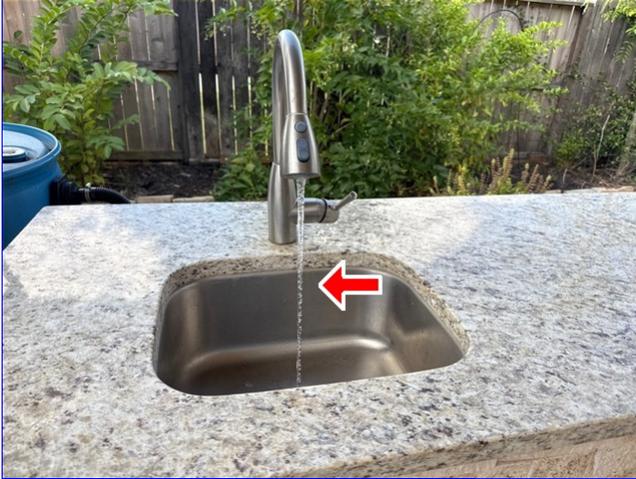
(2) The fixture has weak or restricted flow. Further deterioration can occur. I recommend having a qualified licensed plumbing contractor further evaluate and make repairs as needed.

A. Item 1 (Picture) Outdoor kitchen

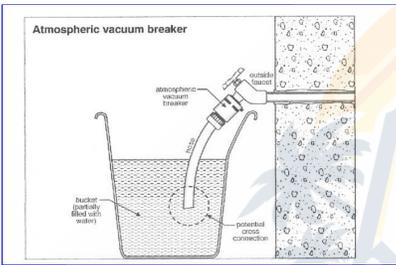
A. Item 2 (Picture)

(3) There is no anti-siphon device installed on the exterior faucet(s). This is not considered today's standard.

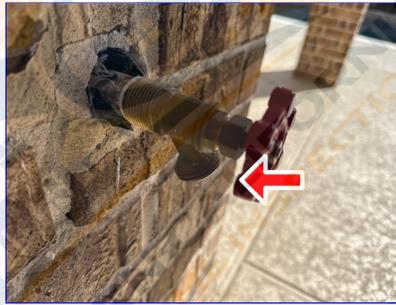
A. Item 3 (Picture) Hose bib at the patio

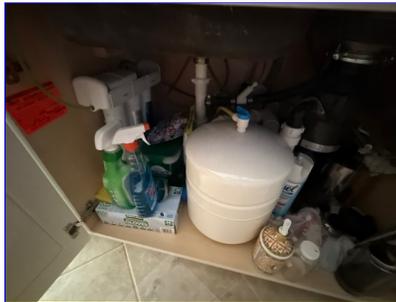
(5) I did not inspect any water filtration or water softener units. I recommend contacting the installer for information on the life expectancy or condition.

A. Item 6 (Picture) Not inspect

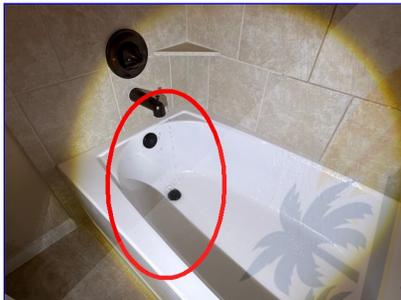
(6) The tub spout leaks when the shower is in use. Further deterioration can occur. I recommend having a qualified licensed plumbing contractor make repairs or replace as needed.

A. Item 7 (Picture) 2nd floor hall bath

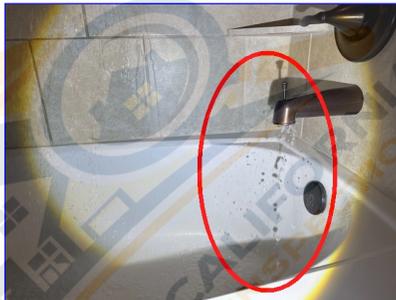
A. Item 8 (Picture) 2nd floor shared bath

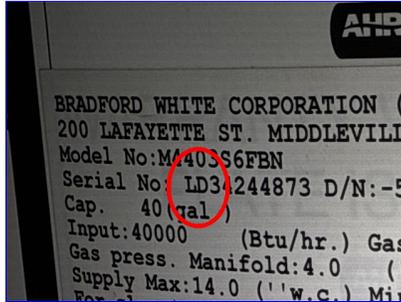
(2) The water heater is built over 10 years and may at the end of its life expectancy. No leaks at present. I recommend having a qualified licensed plumbing contractor make repairs as needed.

C. Item 2 (Picture) Built in 2014

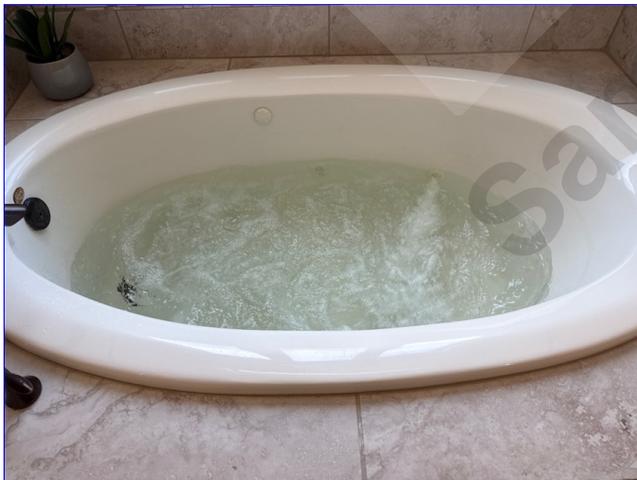
(2) The Hydro-Massage Therapy equipment worked at time of inspection.

D. Item 2 (Picture) Tested

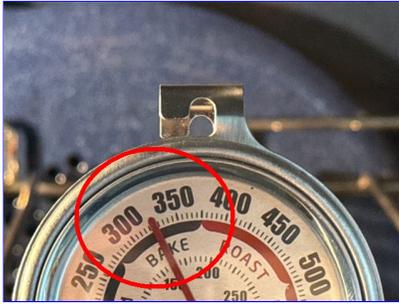
D. Item 1 (Picture) Upper oven tested, setting temperature at 350F

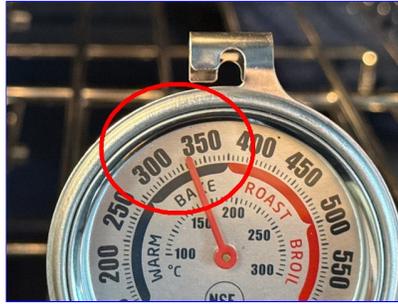
D. Item 2 (Picture) Lower oven tested, setting temperature at 350F

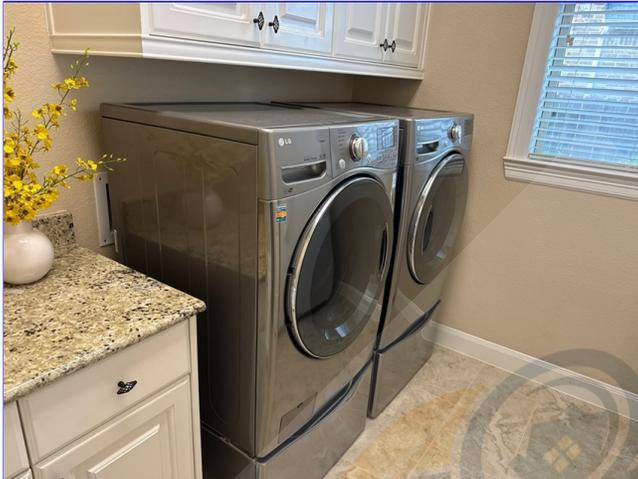
H. Item 1 (Picture) Laundry

The dryer exhaust was not inspected due to the appliances being installed. This is for your information.

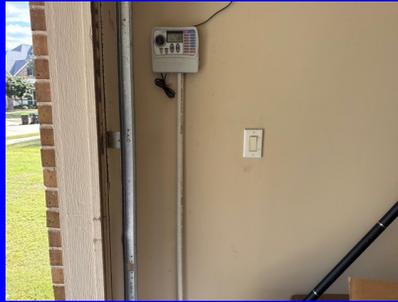
Sprinkler system control panel in garage

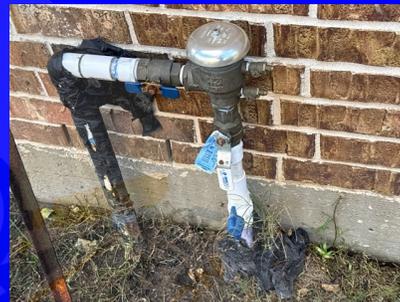
Backflow preventer, right side of home

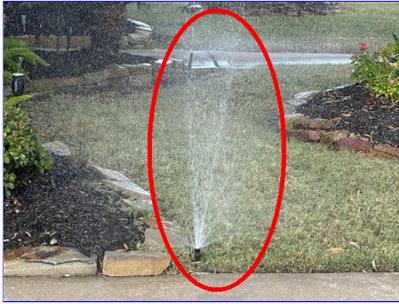
A. Item 17 (Picture) Zone 2

(3) There are two spray heads damaged. I recommend a qualified person to repair as needed.

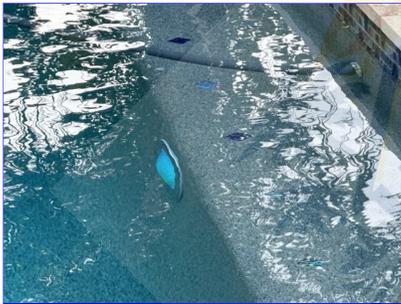
B. Item 5 (Picture) Tested

(4) The pool heater was functional at the time of the inspection.

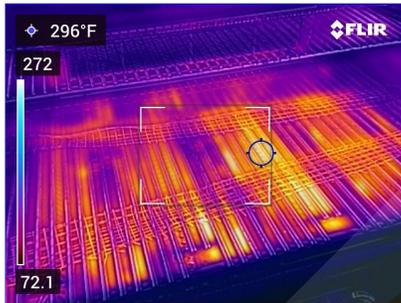
F. Item 1 (Picture) tested

The outdoor cooking equipment did ignite; however, the unit should be cleaned before use. This is for your information.
