Inspection Report

Property Address:
5123 W

SoCal Master Home Inspection

Sample Report

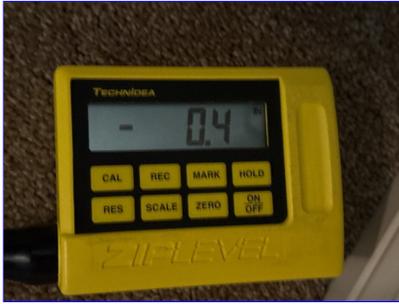
A. Item 1 (Picture) Front right corner

- (1) This is not an engineering report, but is only an opinion based on observation of conditions known to be related to foundation performance, using the knowledge and experience of the inspector.
- (2) The foundation is poured on grade with post tension cables and appears to be performing as designed.

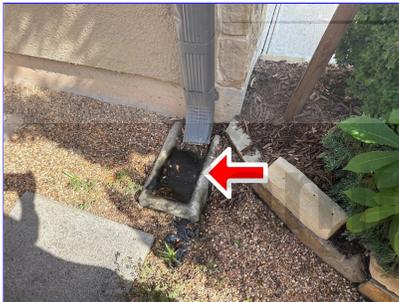
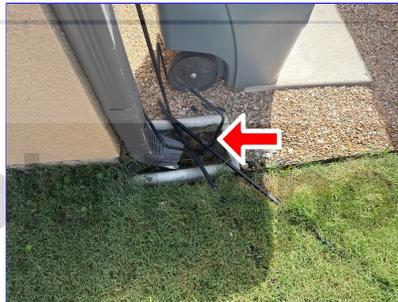
- (1) The gutters appear intact but due to the lack of recent rain, I am unable to determine if gutters leak at seams or spills water.
- (2) The splash-blocks installed backwards at the exterior areas.

B. Item 1 (Picture) Left side of home

B. Item 2 (Picture) Left side of home

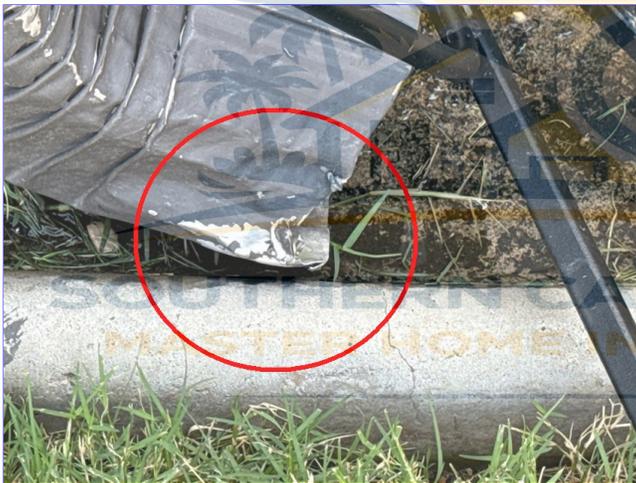
B. Item 4 (Picture) Left side of home

(4) The downspout damaged at the exterior. Erosion can continue or become worse if not corrected. A qualified person should repair or replace as needed.

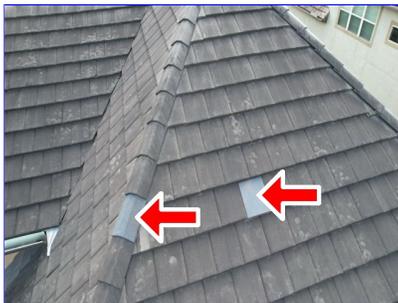
C. Item 2 (Picture) Roof line

(4) The roof shingles has been repaired at the front of home and rear of home. I recommend consulting with a roofing professional.

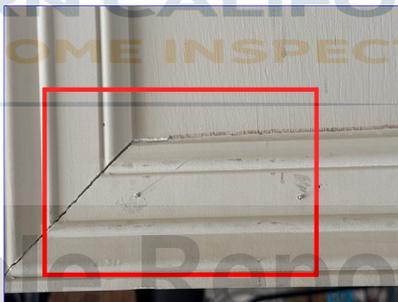
D. Item 2 (Picture) Attic opening at garage in areas

(2) Attic opening cover& frame deteriorated. I recommend a qualified person to repair as needed.

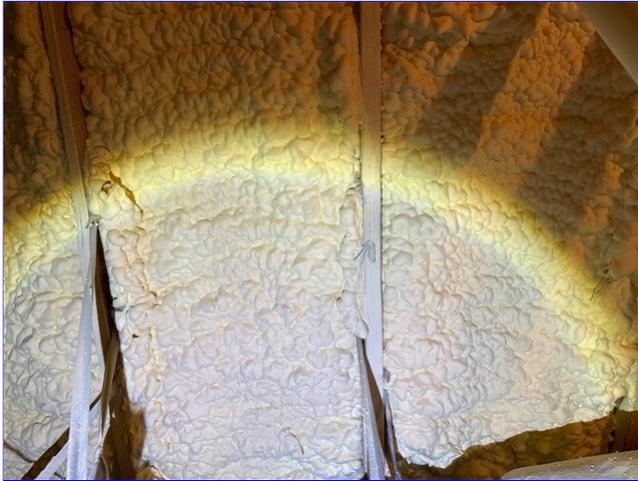
D. Item 3 (Picture) Insulation

(3) Home has spray foam insulation. This can limit visibility for roofing materials. This is for your information.

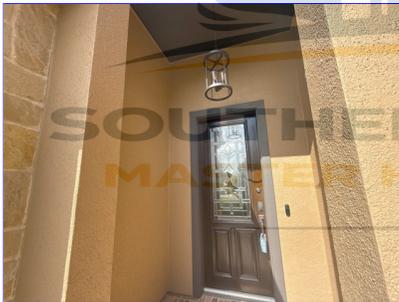
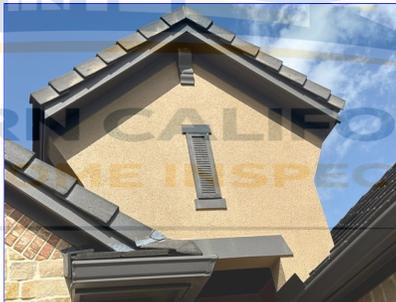
(1) A visual Stucco inspection was performed, however, a certified Stucco inspection will determine if the stucco is holding water behind the siding. A Stucco inspection by a professional Stucco inspector is recommended.

E. Item 1 (Picture) Multiple areas

E. Item 2 (Picture) Multiple areas

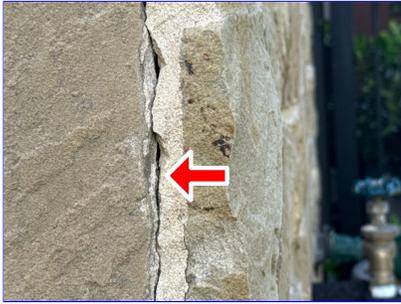
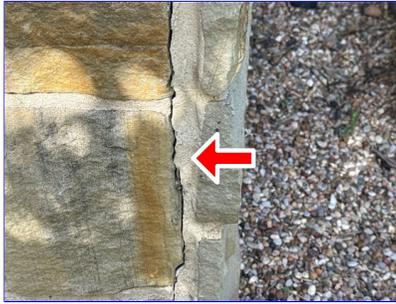
(2) mortar around stone veneers has cracks. I recommend a qualified person to repair as needed.

E. Item 4 (Picture) Right side of home

E. Item 5 (Picture) Right side of home

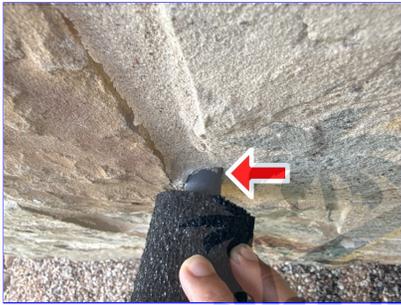
E. Item 6 (Picture) Multiple areas

(3) Areas where wiring or piping passes through walls should be sealed. I recommend having a qualified person seal as needed.

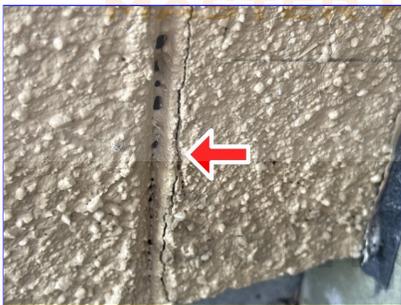
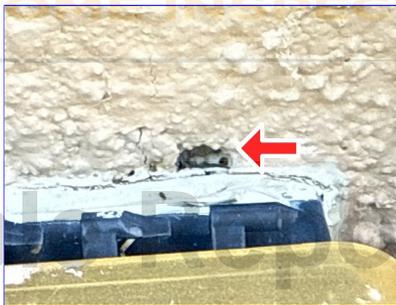
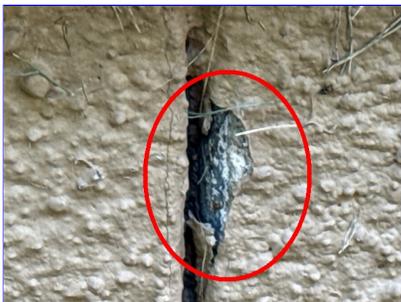
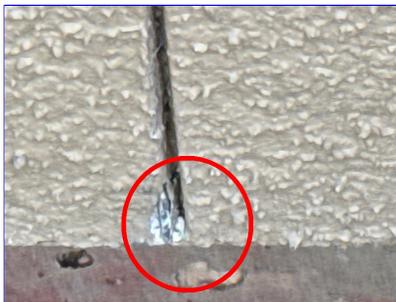
(4) The Stucco coating exterior damaged and has hairline cracks. Further deterioration can occur if not corrected. A qualified stucco contractor should inspect and repair as needed.

E. Item 8 (Picture) Patio area

E. Item 9 (Picture) Rear of home at receptacle area

E. Item 10 (Picture) Rear of home

E. Item 11 (Picture) Rear of home

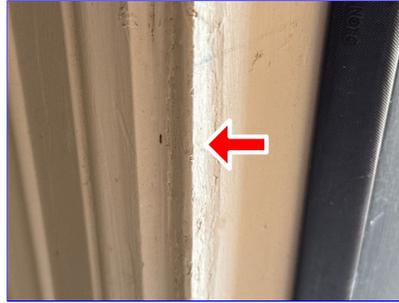
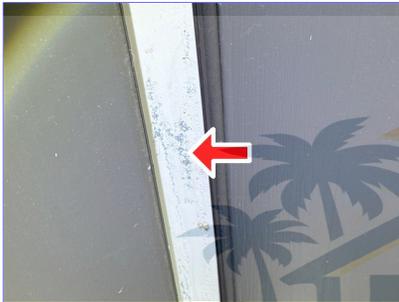
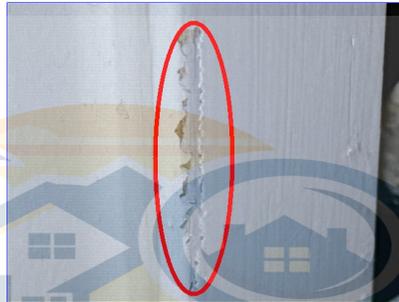
(5) Interior trim is damaged or peeling paint in areas. This is a cosmetic issue. I recommend repair as desired.

E. Item 13 (Picture) Front door jamb

E. Item 14 (Picture) Back door jamb

E. Item 15 (Picture) Multiple door jambs

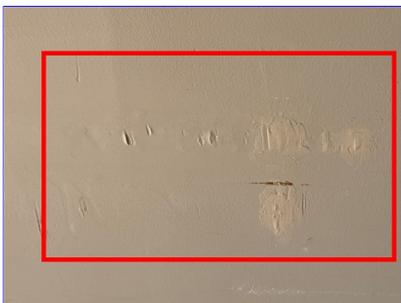
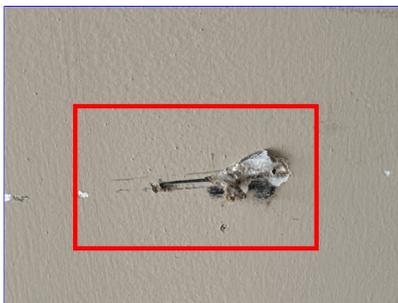
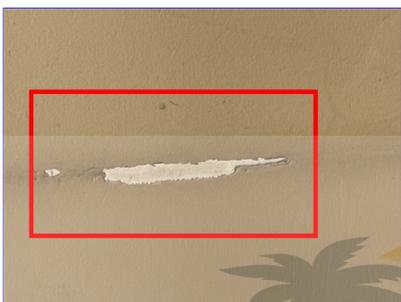
(6) The drywall on the wall is peeling/ damaged. While this damage is cosmetic, it needs to be repaired. A qualified person should repair or replace as needed.

E. Item 16 (Picture) Garage in areas

E. Item 17 (Picture) Garage in areas

E. Item 18 (Picture) Garage in areas

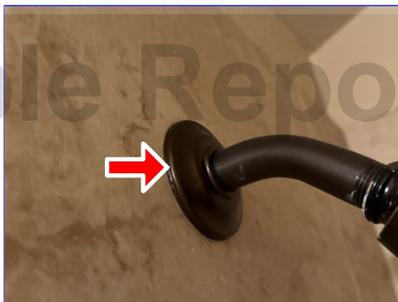
E. Item 26 (Picture) Bath at the 2nd floor

(9) The Surround kit for shower on the wall missing silicone caulking around control knob cover-plate/ shower head at the hall bath. Repairs are needed. A qualified person should repair or replace as needed.

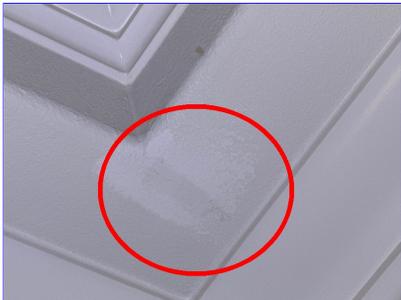
F. Item 2 (Picture) Front door at ceiling in areas

(1) The Drywall on the ceiling is peeling in areas and needs prep and paint in areas. While this damage is cosmetic, it needs to be repaired. A qualified person should repair or replace as needed.

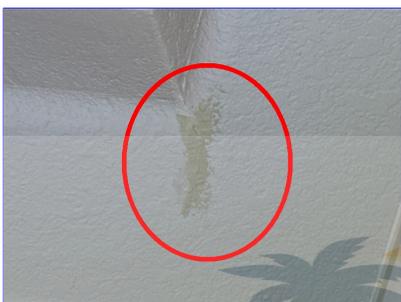
F. Item 4 (Picture) Multiple areas

(2) The Drywall on the ceiling shows repair signs in areas. While this damage is cosmetic, it needs to be repaired. This damage is considered cosmetic. A qualified person should repair or replace as needed.

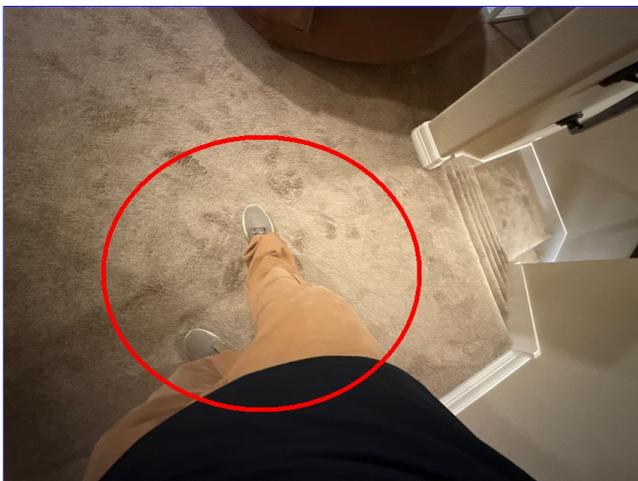
F. Item 8 (Picture) 2nd floor gaming room

(3) The sub floor at the 2nd floor and stair step make squeak noise sound. I recommend a qualified person to repair as needed.

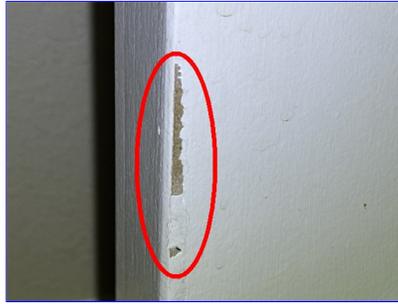
G. Item 3 (Picture) Guest bedroom door

(2) The entry doors torn or peeling paint. This is a maintenance issue and is for your information. A qualified person should repair or replace as needed.

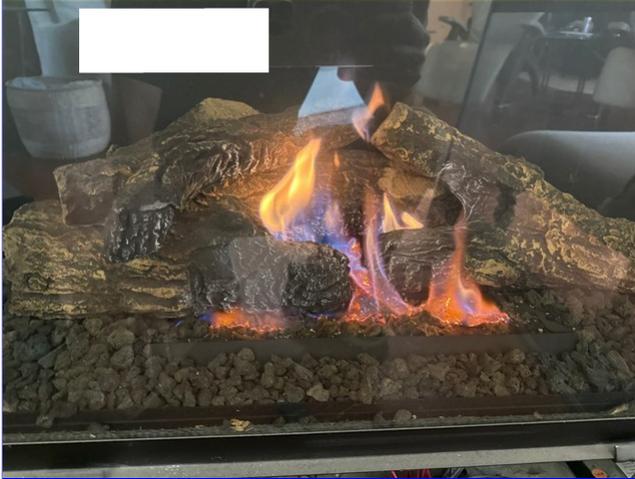
J. Item 1 (Picture) Tested

(3) Gas log fireplace would not lite by using remote control when tested. I recommend having sellers demonstrate.

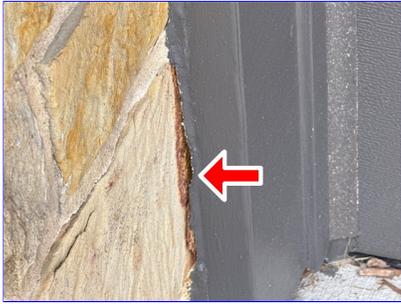
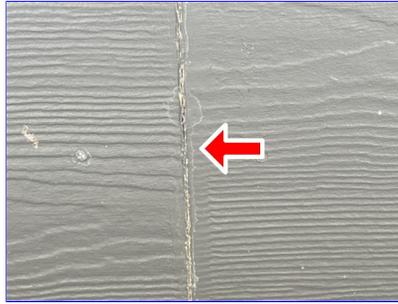
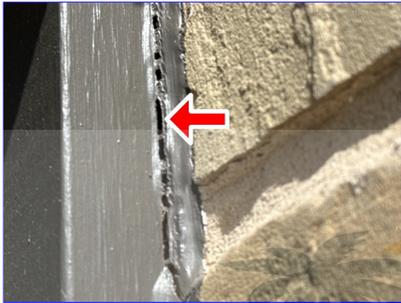
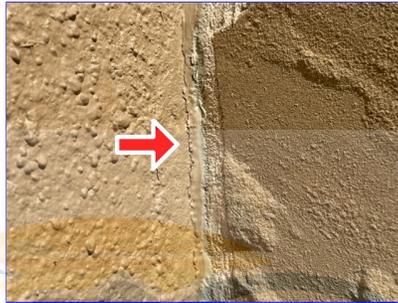
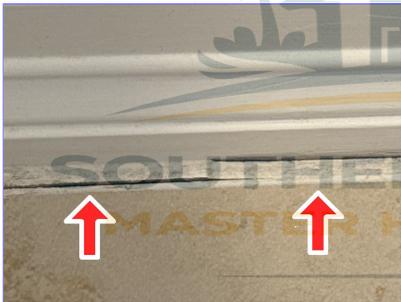
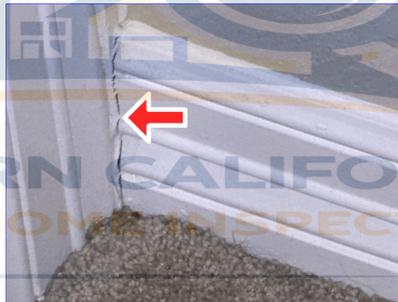
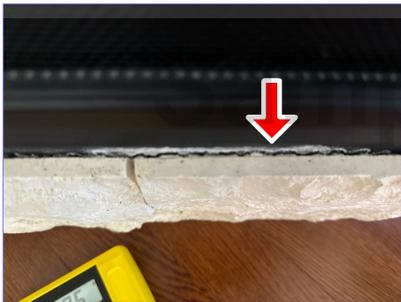
(1) Areas of the home have caulking or grout missing or damaged. Deterioration could occur if not corrected. I recommend having a qualified contractor inspect and make repairs as needed.

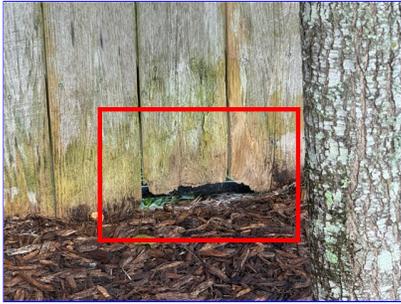
L. Item 8 (Picture) Multiple areas

(2) Fence is deteriorated/damaged in areas. Recommend repair or replace by a qualified contractor.

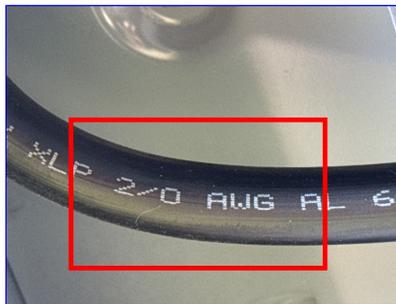
A. Item 5 (Picture) 150 amp service wires

(4) Service wiring does not appear to be the proper size for main disconnect in panel. This is safety issue. I recommend further evaluation by a qualified electrician.

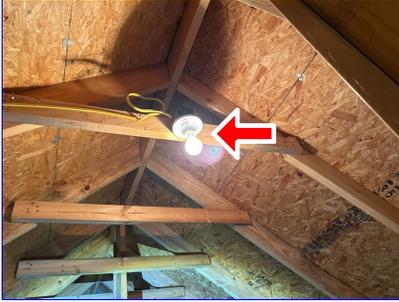
B. Item 4 (Picture) Attic light (garage)

- (4) Light fixture(s) is missing cover in the attic space. Recommend repair or replace as needed.

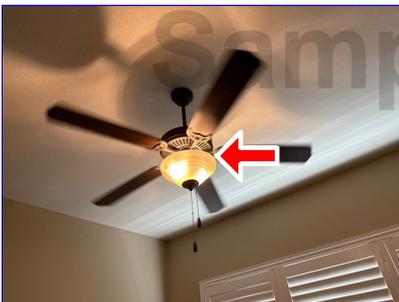
B. Item 7 (Picture) Front guest bedroom

(6) After running the ceiling fans, I can hear a noise that sounds like an electric current. I recommend a qualified person to inspect as needed.

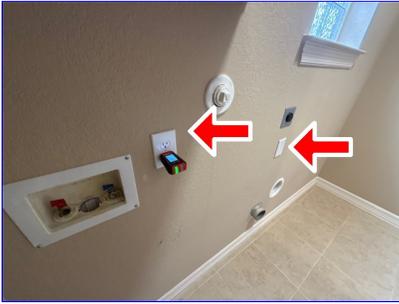
B. Item 9 (Picture) Laundry

(7) There are no GFCI protected circuits in required area's. This is not considered to be today's standard. I recommend having a qualified electrician make repairs as needed.

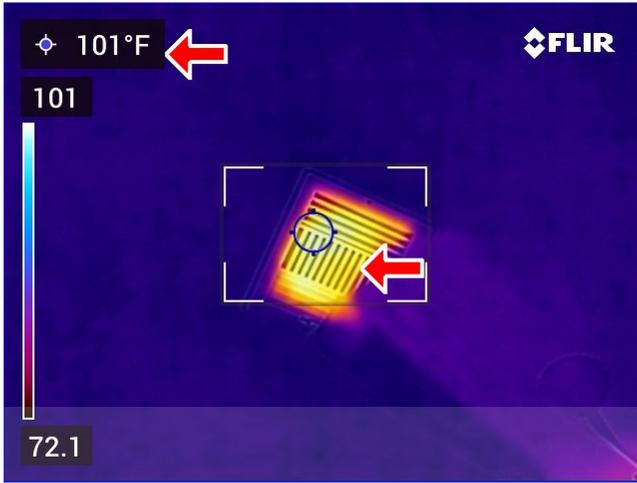
A. Item 1 (Picture) heating supply

- (1) It is recommend to have heating systems serviced annually.
- (2) Tested and working properly at the time of inspection.

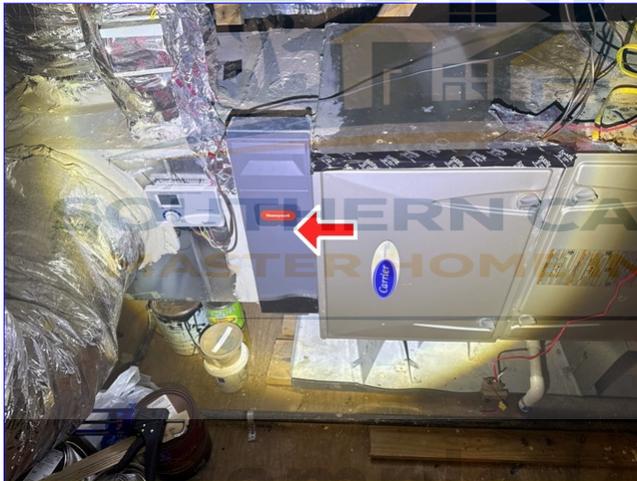
A. Item 2 (Picture) Left side of furnace

- (3) The filter location is in the attic.

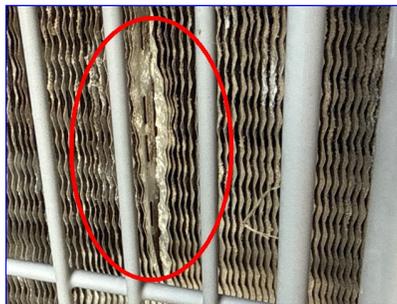
B. Item 4 (Picture) Condenser

(3) Condenser coil at exterior of home is damaged in areas. This damage can shorten the life expectancy of the unit. I recommend having a qualified HVAC company inspect and make repairs as needed.

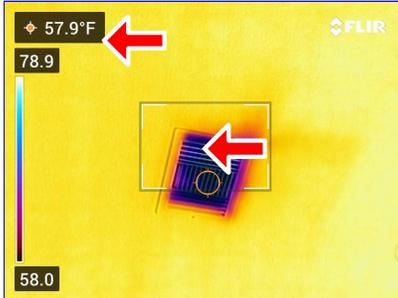
conditioner to determine if the difference in temperatures of the supply and return air are between 15 degrees and 22 degrees which indicates that the unit is cooling as intended. The supply air temperature on your system read 58 degrees and the return air temperature was 73 degrees. This indicates the range in temperature drop is normal.

B. Item 5 (Picture) cooling supply

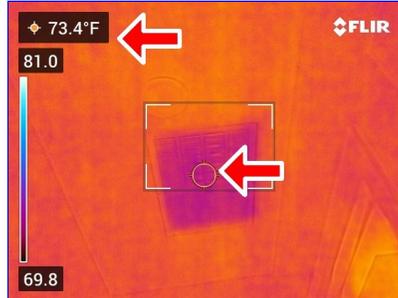
B. Item 6 (Picture) cooling return

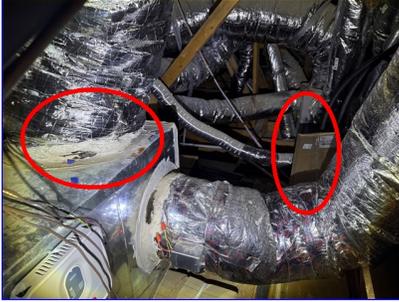
C. Item 1 (Picture)

- (1) I recommend changing all HVAC filters upon move in.
- (2) The plenums is not taped properly and air leakage in the attic. Energy loss is occurring in crawlspace and immediate correction is needed. A licensed HVAC contractor should service or repair unit.

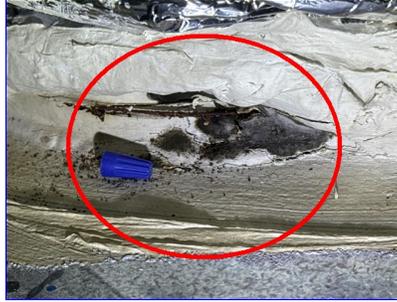
C. Item 2 (Picture) Mold presents

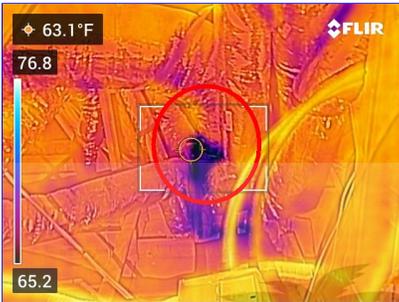
C. Item 3 (Picture) air leakage is happening

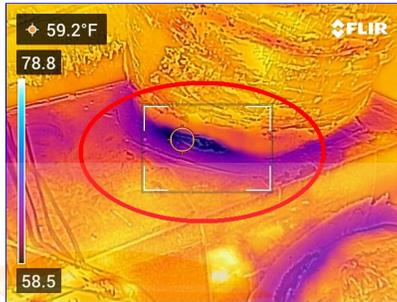
C. Item 4 (Picture) air leakage is happening

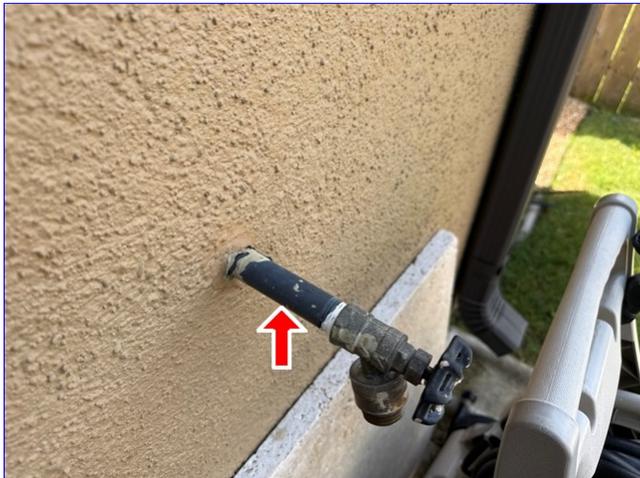
(2) Supply line is not properly insulated in areas. I recommend having a qualified plumber inspect and repair as needed.

A. Item 1 (Picture) Rear hose bib

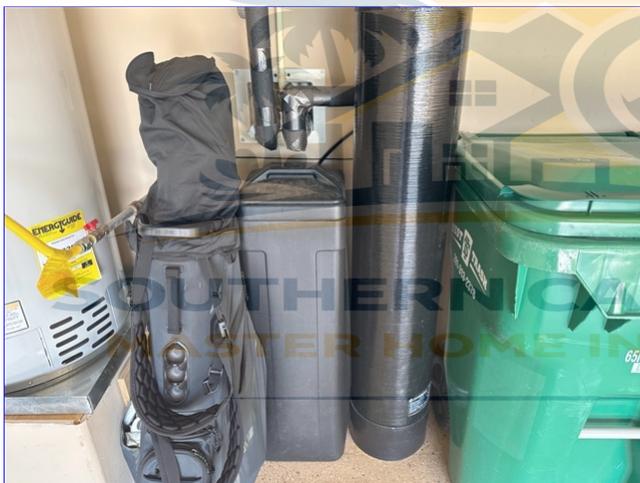
(3) I did not inspect any water filtration or water softener units. I recommend contacting the installer for information on life expectancy or condition.

A. Item 2 (Picture) Not inspect

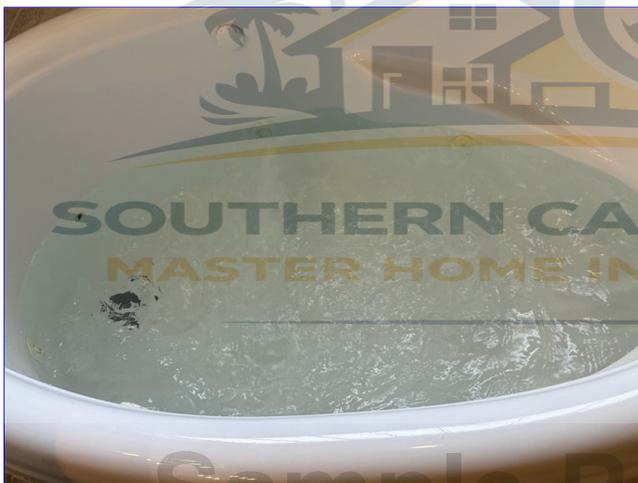
(2) The Hydro-Massage Therapy equipment worked properly at time of inspection.

D. Item 2 (Picture) Tested

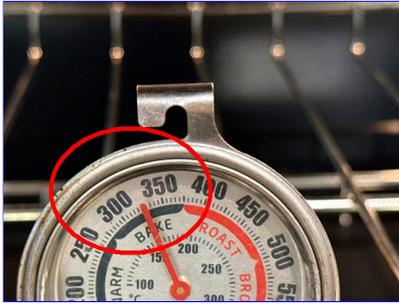
D. Item 1 (Picture) Tested, setting temperature at 350F

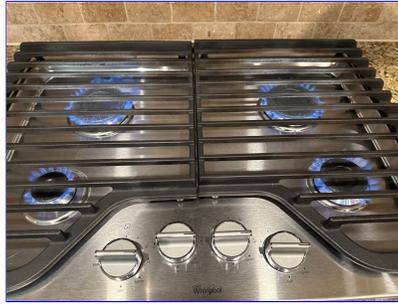
D. Item 2 (Picture) Tested

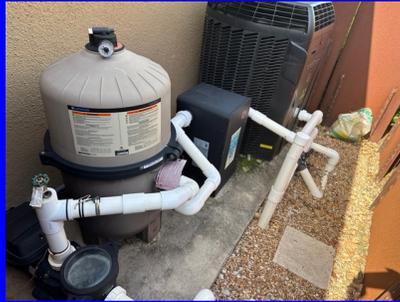
Pool equipment, right side of home

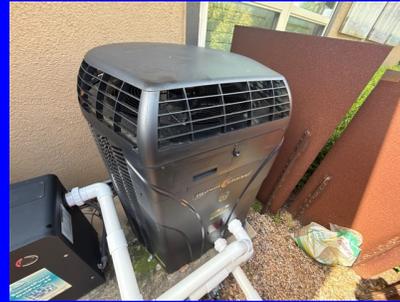
Pool heater

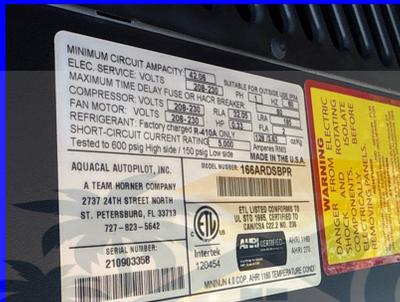
Pool heater, date of plate

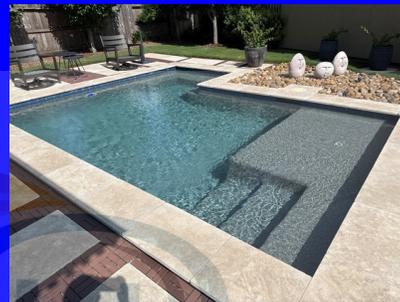
Pool overview

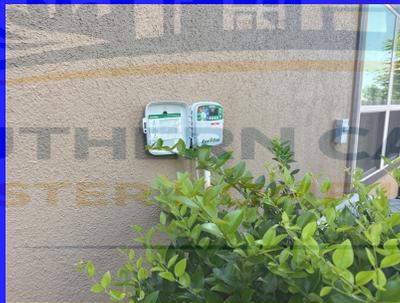
Sprinkler system control panel, rear of home

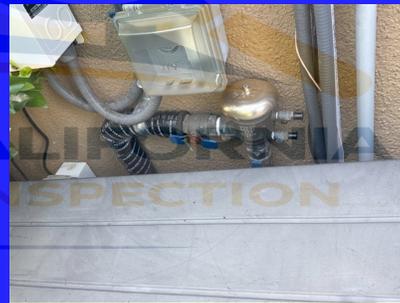
backflow preventer, right side of home

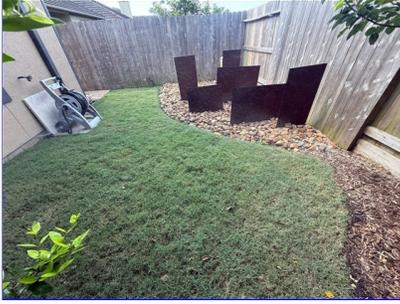
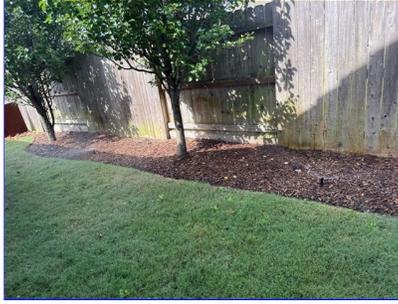
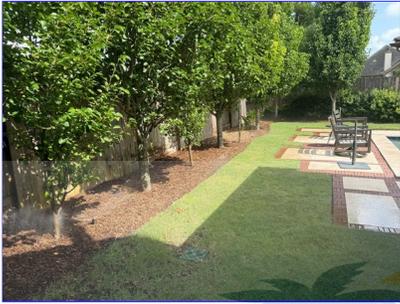
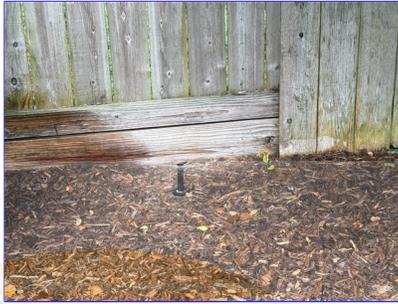
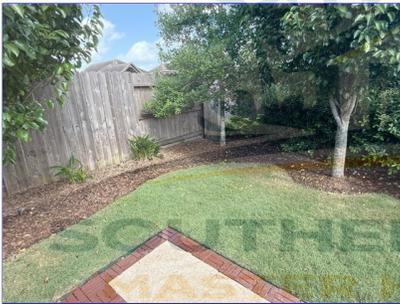
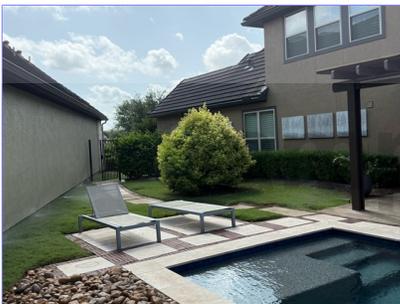
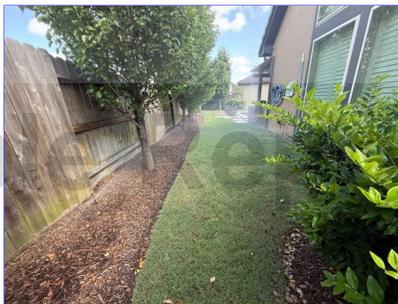
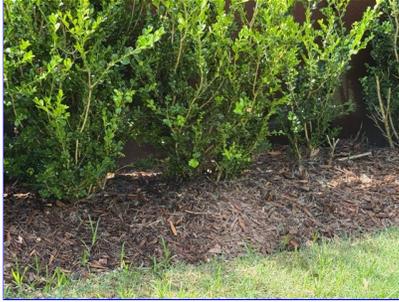
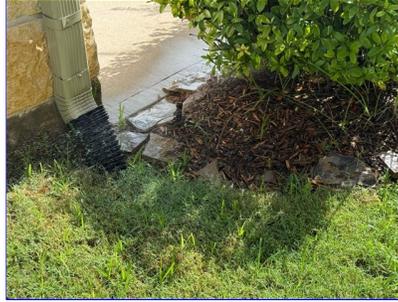
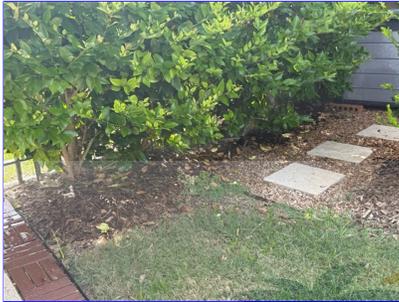
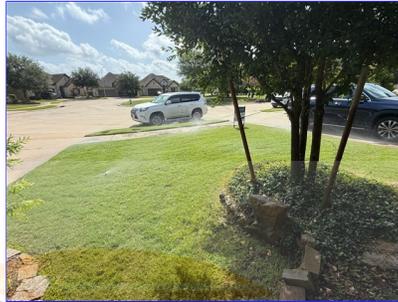
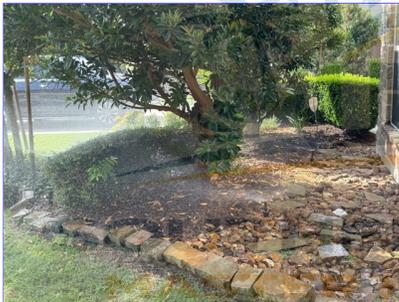
Tested and working properly at the time of inspection however some sprinkler heads spray patterns will need adjustment or replacement.

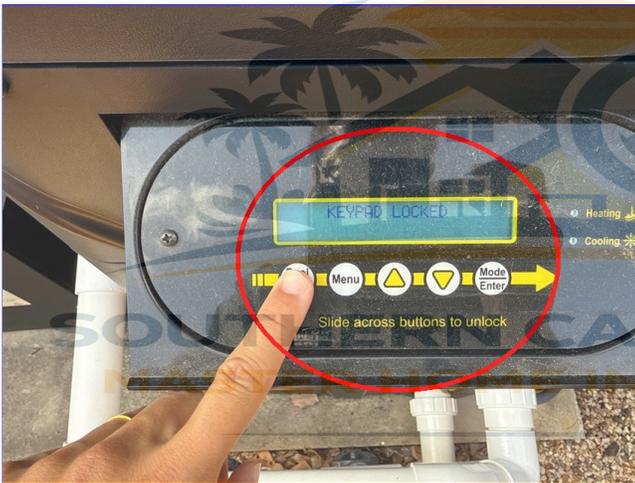
(4) Unable to test the pool heater due to it locked off by owner.

B. Item 2 (Picture) Pool heater setting panel

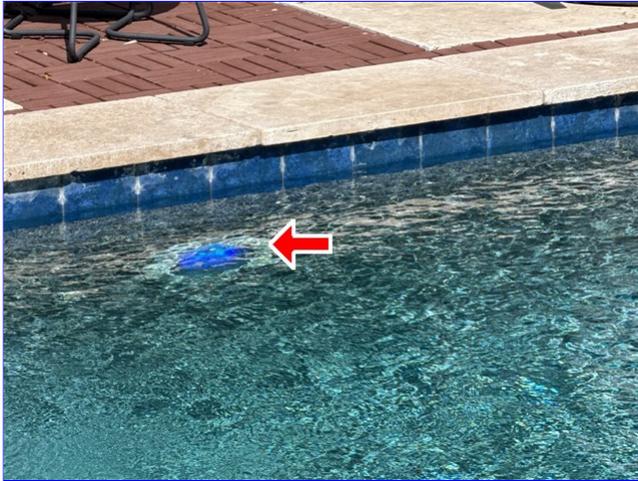
(5) Light in the pool tested.

B. Item 3 (Picture) Light tested

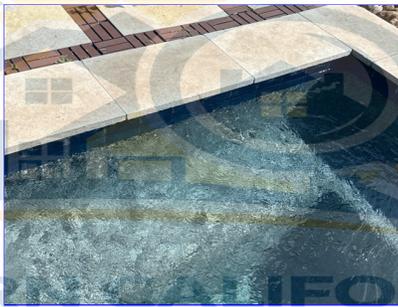
(6) I did not find how to turn down the blower/ jets/ pump for the pool at the control station. I recommend the buyers get more info. from the owner.

B. Item 5 (Picture) not turn off

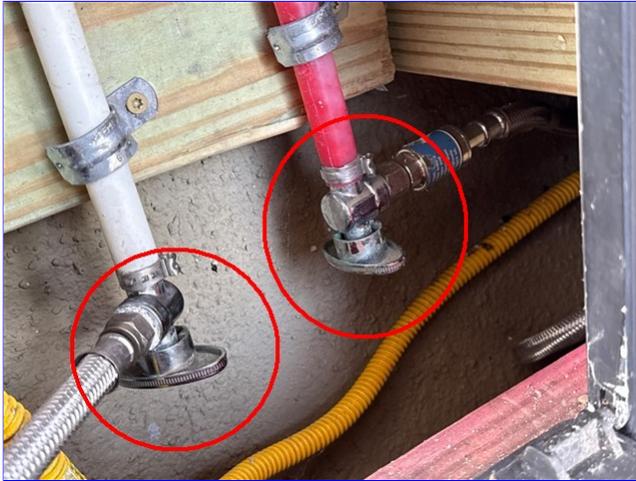
F. Item 1 (Picture) Patio area

(1) The water shut off by owner, did not inspect the condition of faucet for outdoor kitchen.

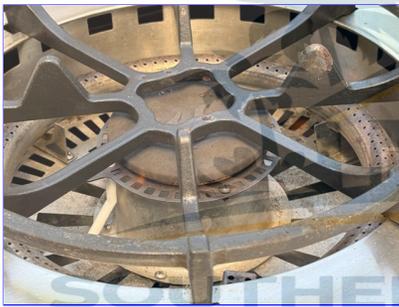
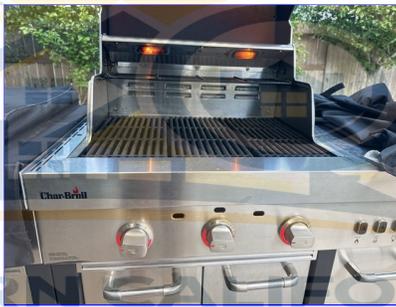
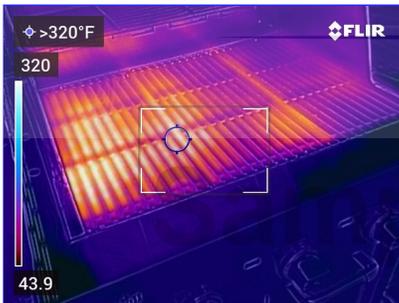
(2) Outside cooking equipment did ignite at time of inspection process, however unit should be cleaned before use. This is for your information.
